Burlington High School

OVERVIEW

This Study documents the recent survey done to seven different schools in the Burlington School District. The survey focused on the condition of the architectural finishes, building envelope and a general assessment of the mechanical, electrical and plumbing systems.

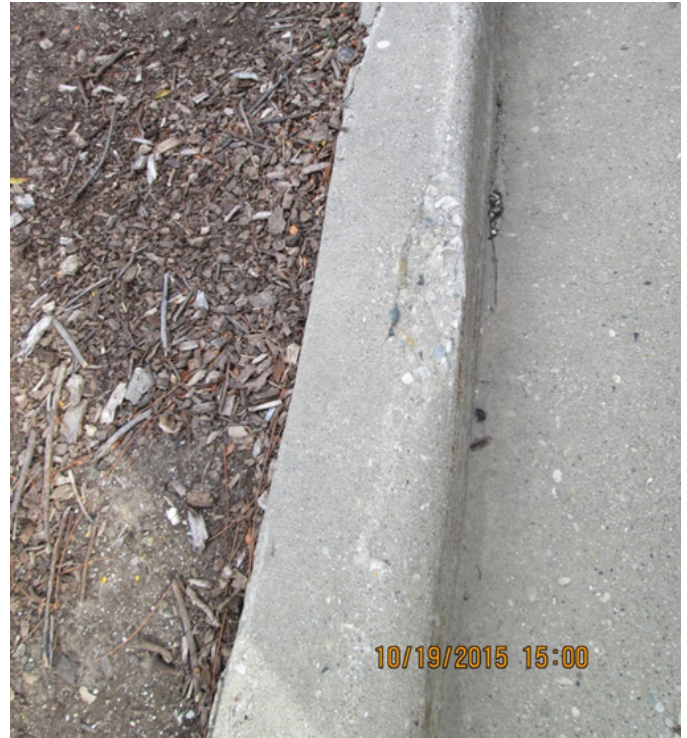
The sidewalks and concrete paved areas are generally in good condition. Some concrete pavement spalling is evident at the receiving area. Some concrete curbs are cracked or damaged apparently from snow removal equipment. The dock leveler located at the receiving area shows through-rust on the top plate. The asphalt driveway shows some wear and was previously repaired with pavement crack infill. The asphalt parking and paint stripping is fading and showing wear.

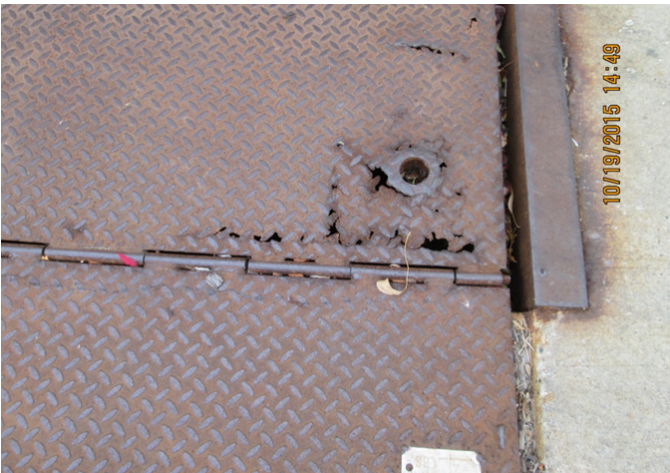
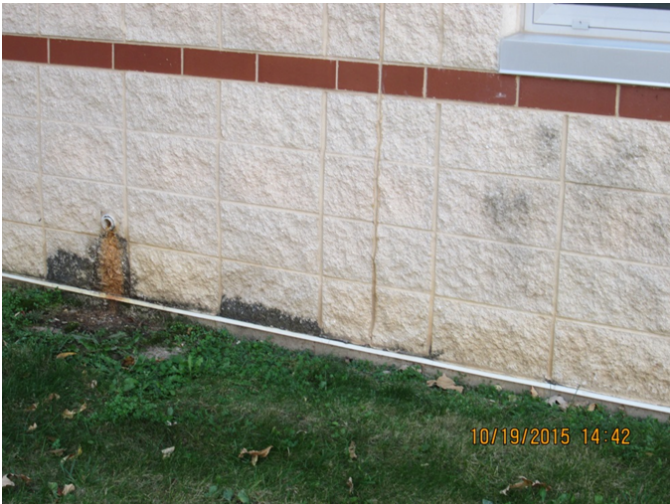
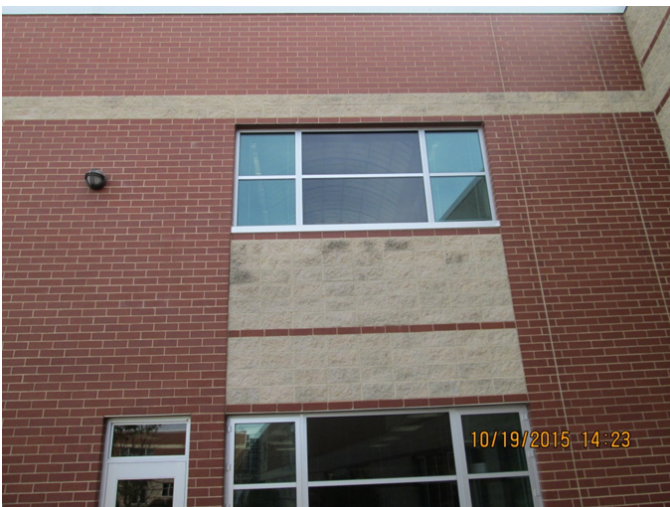
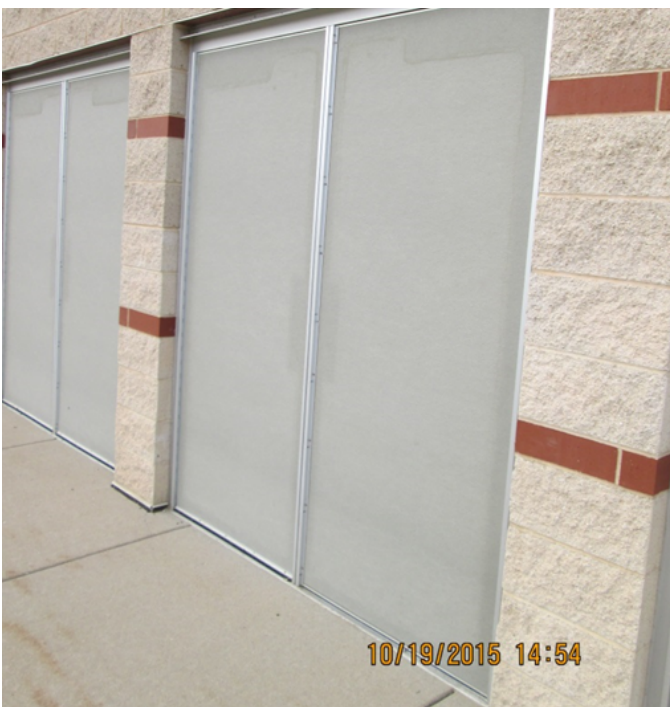
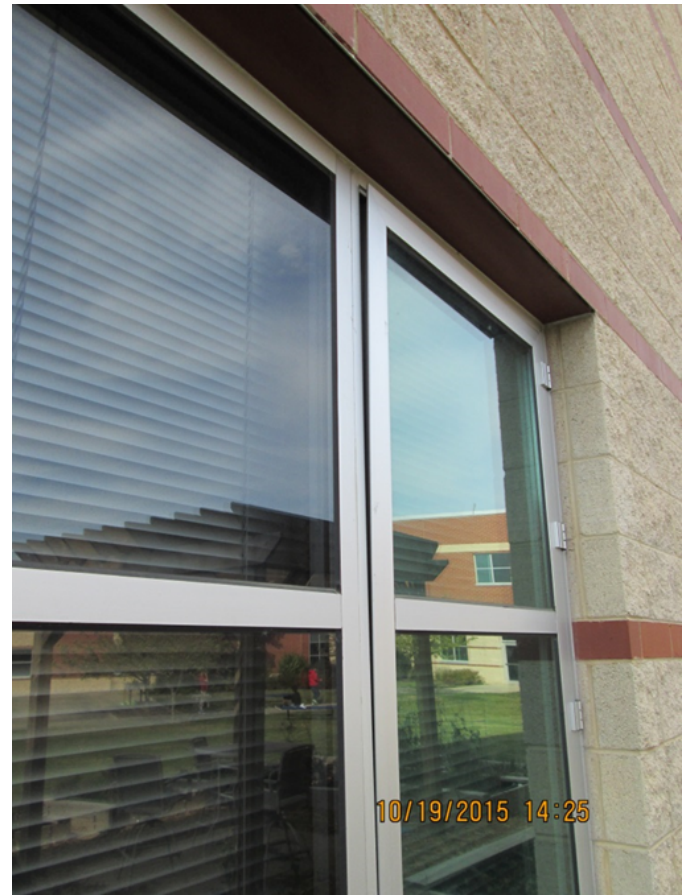
The building exterior cladding consists of light colored split faced concrete masonry units (CMU) and red face brick. The bricks appear to be in very good condition with very minimal areas showing efflorescence staining. The CMU walls show some dark staining in various areas. The front entrance canopy has an exterior insulated finishing system (EIFS) soffit which shows some staining. The exterior aluminum windows have insulated glass units and are mostly in good condition. However, there are a few windows units that appear to be warped and in need of some servicing. The exterior fiberglass gym doors appear to be faded and are showing some wear. Most of the exterior steel doors appear to be in fair condition; except Door 11 has some damage to the weather stripping and rust on the bottom of the door frame.

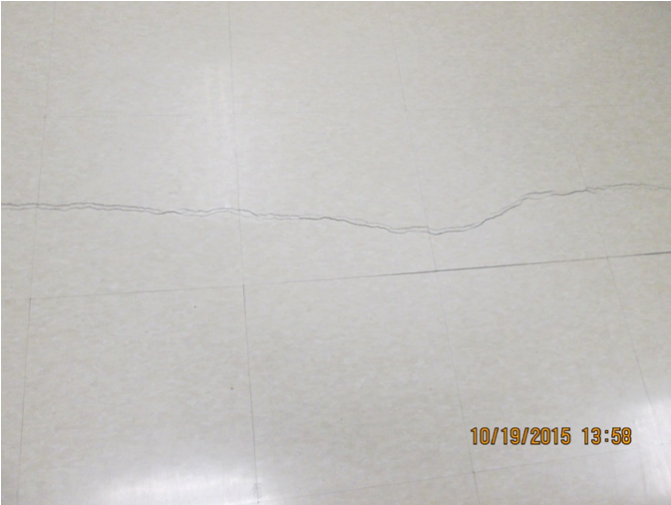
Most of the acoustical ceiling panels are in good condition with approximately 2% to 4% requiring replacement due to water damage, physical damage or staining. The walls mostly consist of painted CMU. The corridors have red painted split faced concrete block up to 2'-0" high and white painted smooth CMU above. The dark red paint is in good condition, but is starting to show some wear. The wood doors along the corridor are mostly in good condition with some minimal staining and scratches; however, the painted steel frames are showing some wear. Some areas of gypsum board soffits are cracked and stained requiring minimal repairs. Most lockers along the corridors are in good condition. The vinyl composition tile (VCT) floors are mostly in good condition. However, there are a few areas with cracked tiles.

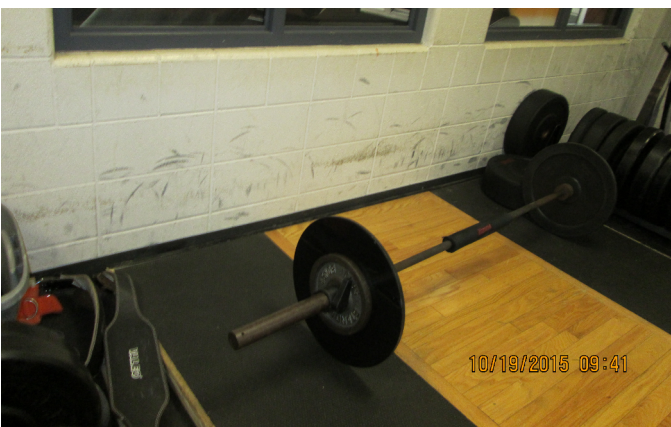
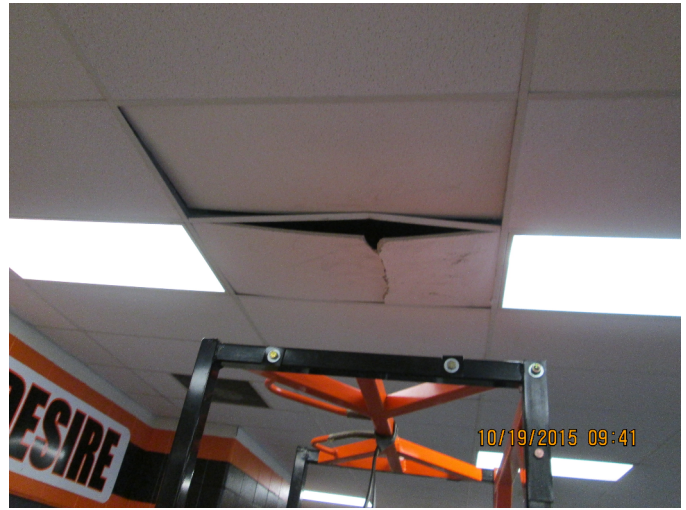
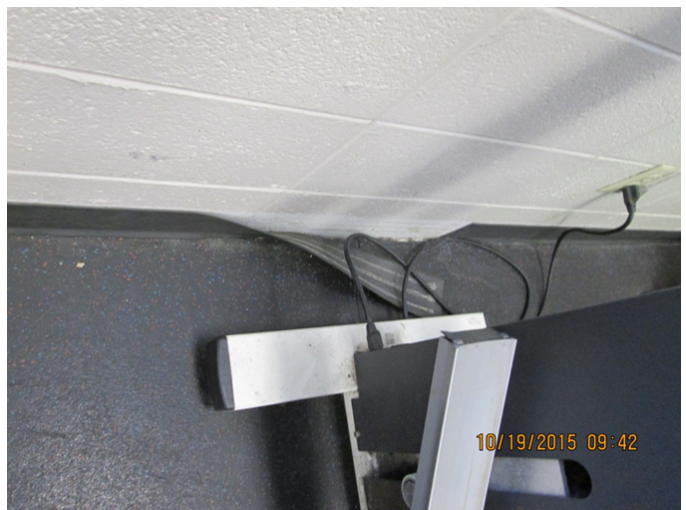
The Weight Room 137 is in fair to poor condition with stained and scuffed painted walls, damaged and stained ceiling tiles, damaged and missing vinyl wall base, dented and cracked VCT floor and damaged electrical outlet

covers.

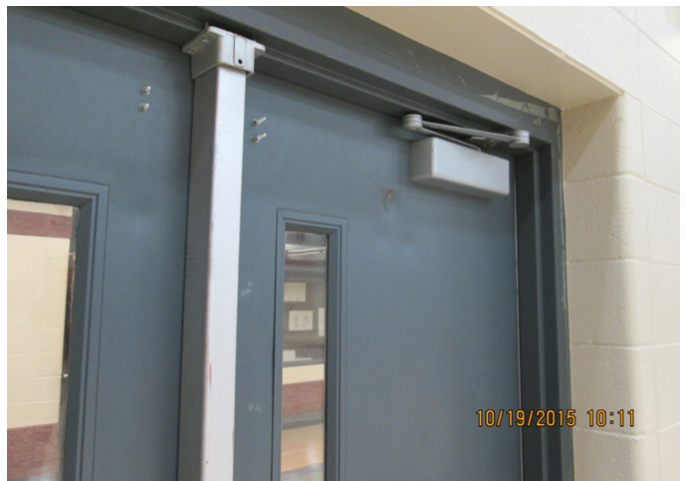
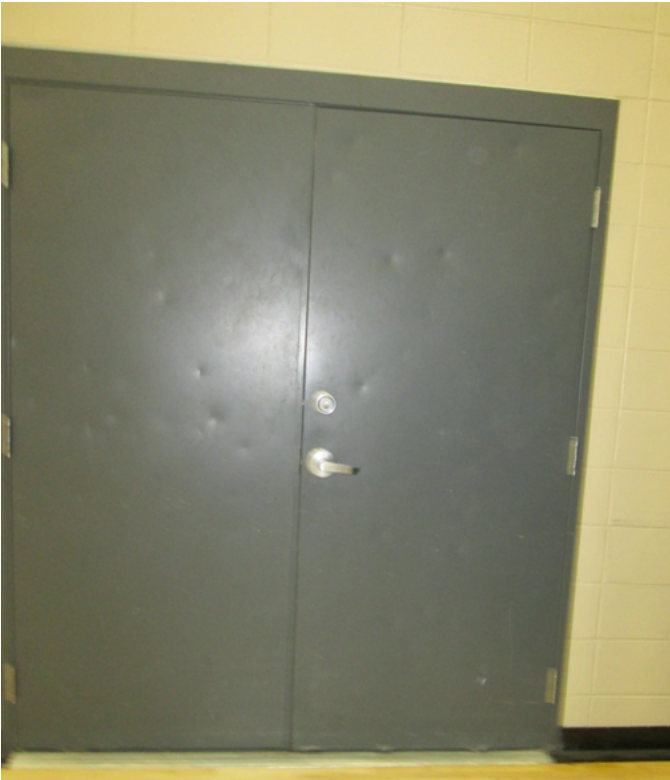
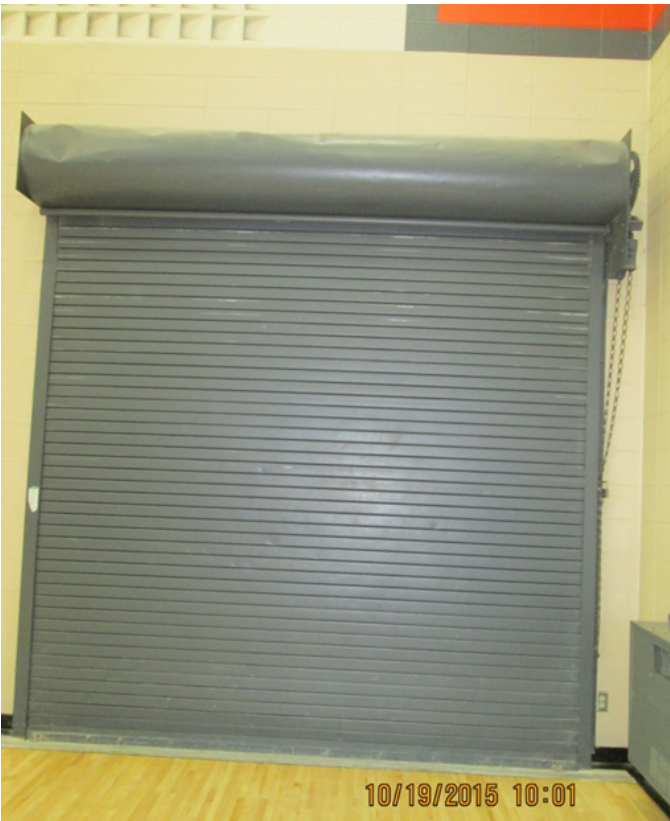
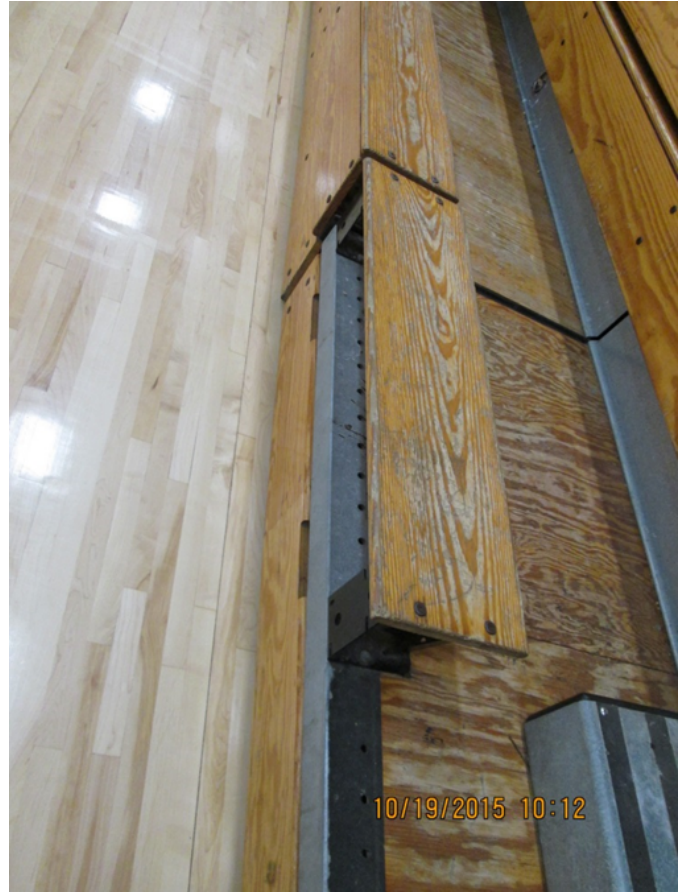
The Gymnasium is generally in good condition. Most of the wear and tear is evident on the dented metal doors. The finish on the wood bleachers has worn down to bare wood primarily on the first row.

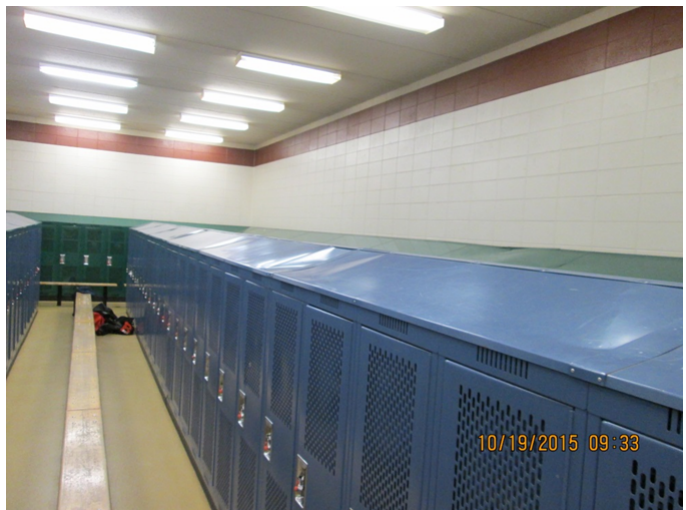
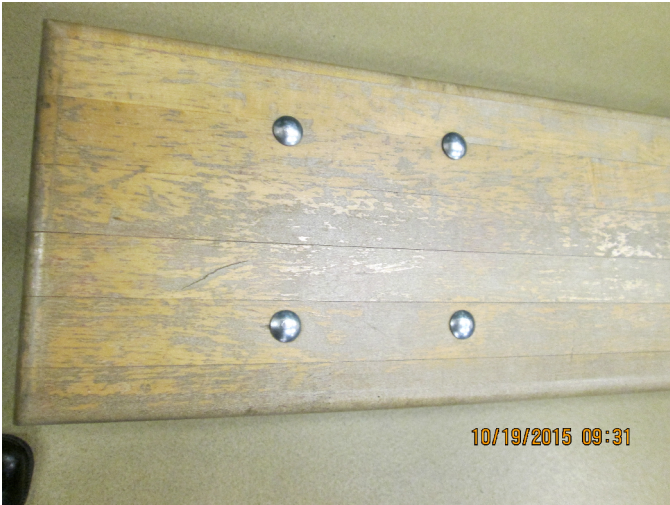
The Locker Rooms are generally in good condition. There is damage evident on the slope tops on some of the lockers and the finishes on wood benches are worn down.

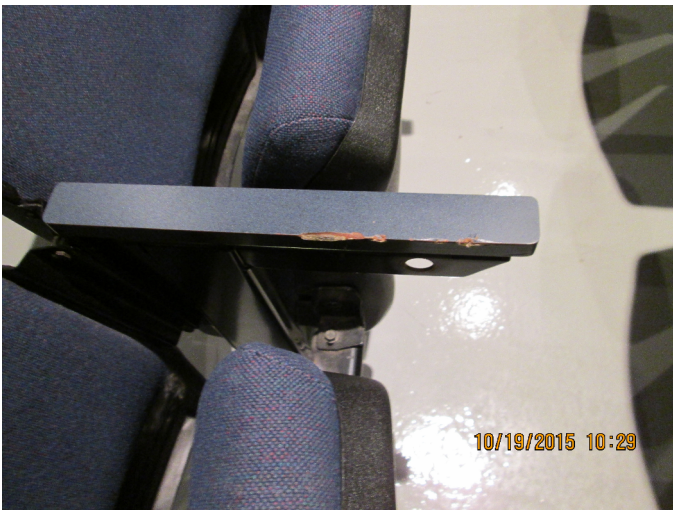
The Auditorium is generally in good condition. However, the wear and tear is evident on the auditorium seating. Approximately, 15% of the plastic laminate arm rests and approximately 3% of the upholstery has some damage
