BURLINGTON ARCHITECTURAL SUMMARY

COOPER ELEMENTARY SCHOOL

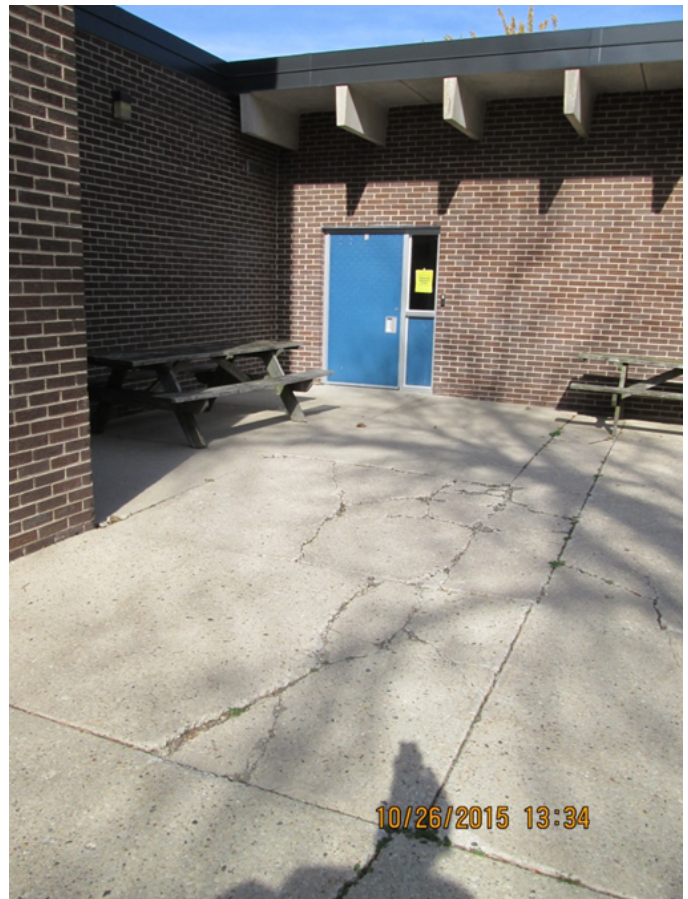
The sidewalks and concrete paved areas around the site are in fair condition. However, the pavement near Door #6 is badly cracked. Since it is located outside of the Kitchen Area, the damage may have been caused by heavy delivery trucks.

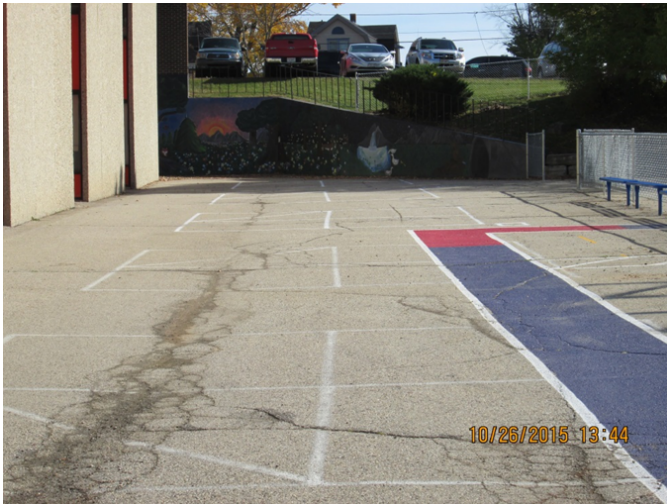
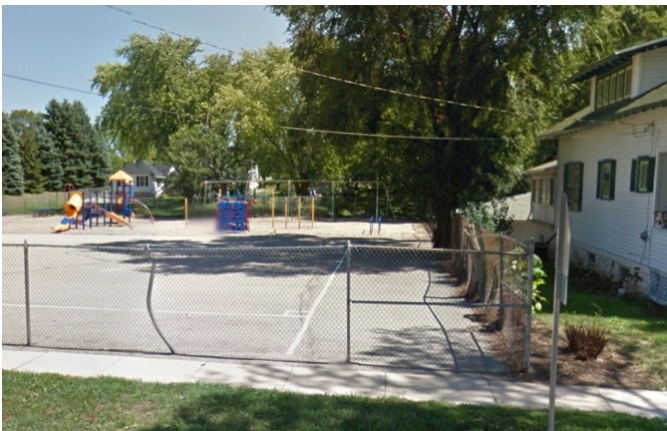
The asphalt paved playground area is in poor to fair condition with several areas with cracked and uneven surfaces and worn out paint stripes. The playground equipment on the wood chips appear to be in fair to good condition. The wire mesh fencing is generally in good condition, except for the southwest corner adjacent to a residential property. The top of rails and post are damaged.

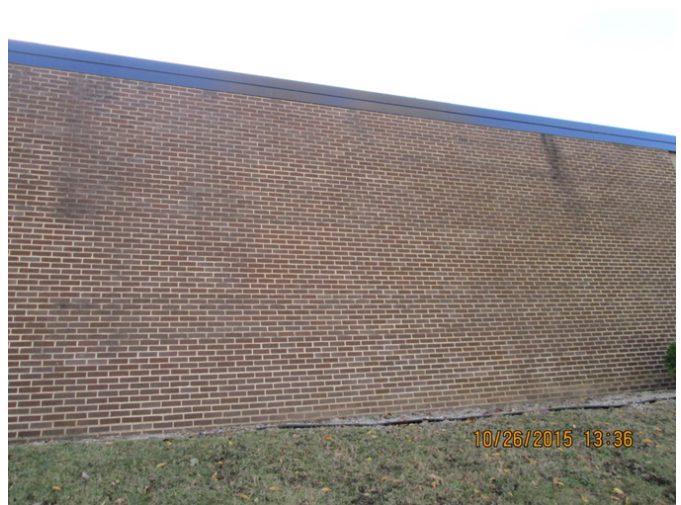
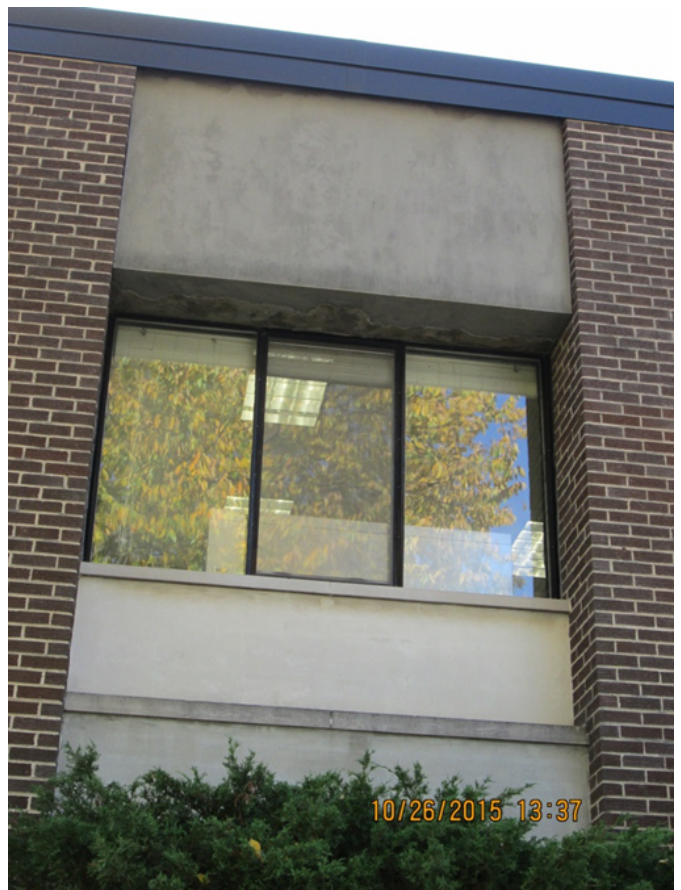
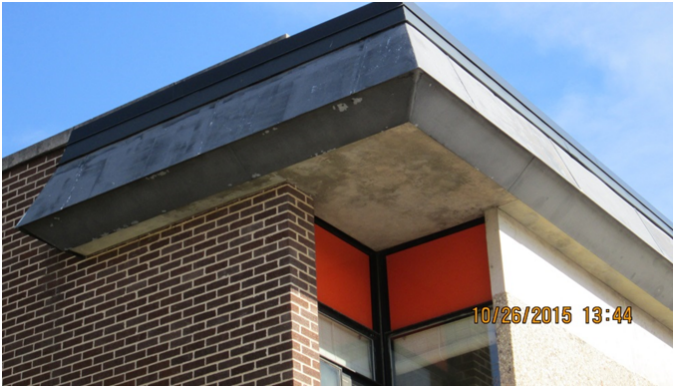
The building exterior cladding primarily consists of red face brick with some lime stone sills and coping. There are walls with exposed aggregate precast concrete and some exterior insulated finish system (EIFS) wall panels and soffits. The bricks generally appear to be in good condition with some surface rust stains on various areas of the building. The precast concrete panels also appear in good condition; but the EIFS panels and soffits are heavily

stained. Most of the limestone sills and coping are stained. The angled metal fascia on the west façade are faded and stained. Some rusty abandoned electrical conduits are left on the brick wall adjacent to the main entry to the building.

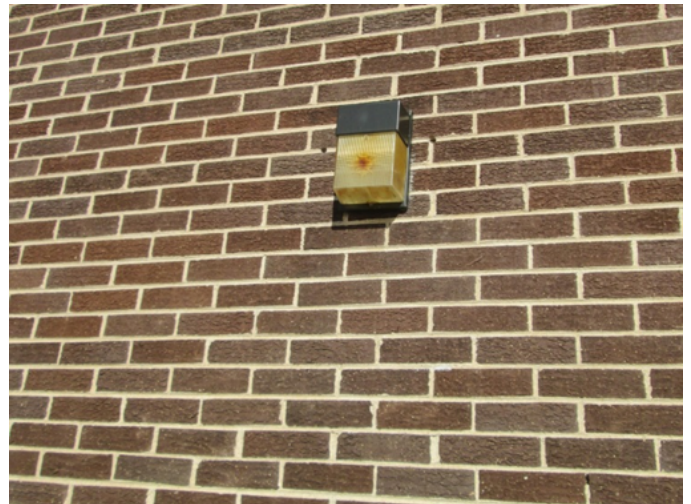
Most of the soffits are constructed of EIFS and are heavily stained. The lenses on the light fixtures mounted on the building exterior walls are discolored and the fixture housing are faded.

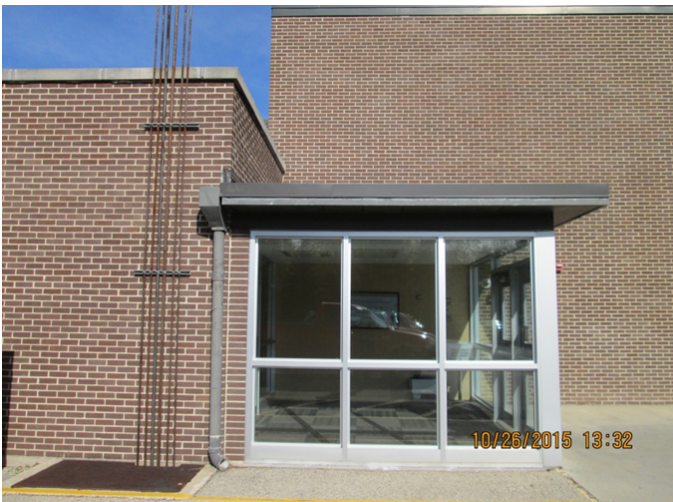
However, the sealant joints between the precast concrete panels; pavement joints and around the windows are deteriorating and around the window will need replacement.

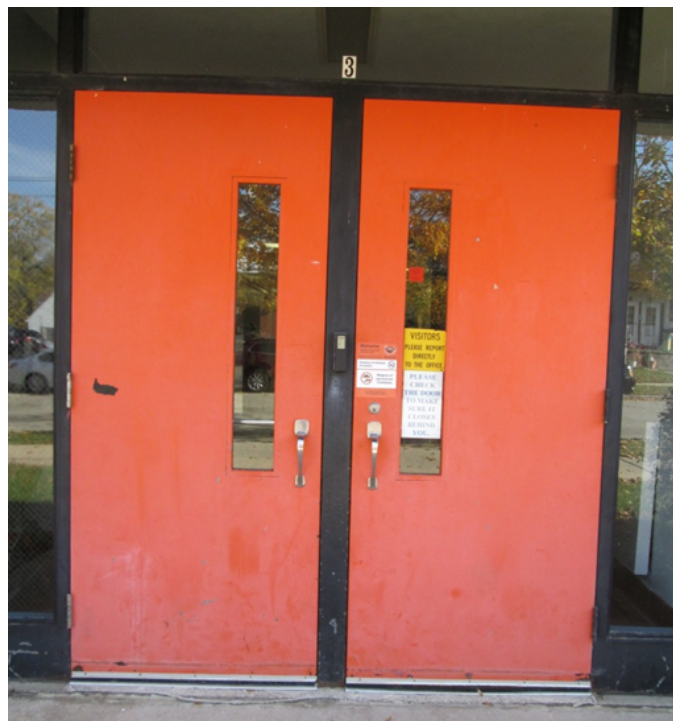
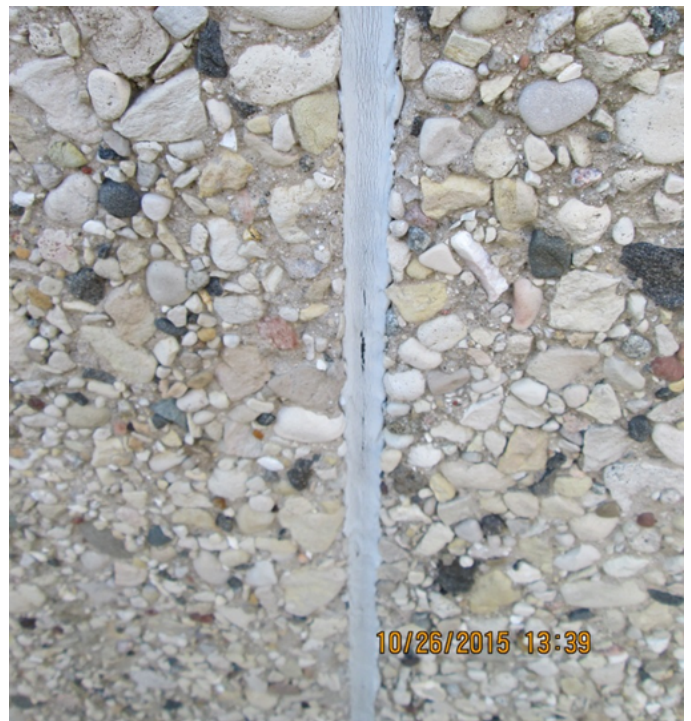
The aluminum storefront appear to be in good condition. However, the painted steel storefronts are faded, stained, with chipped paint and with rusted areas.

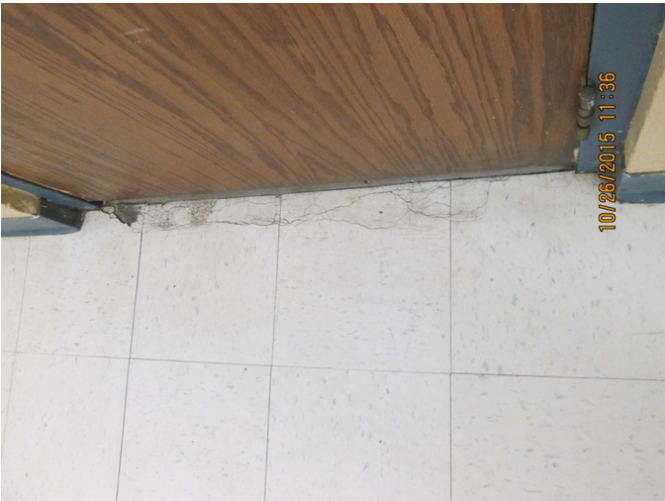
The acoustical ceiling panels in the corridors are in fair to good condition with approximately 2% requiring replacement due to water damage, physical damage and/or staining. The corridor walls are generally in good condition and consist mostly of painted insulated metal panels and painted concrete masonry unit (CMU). The corridor doors are stained and varnished oak veneer and are in fair condition with some scratches, marks and dents. Approximately 10% of the doors are in poor condition with large gouges and missing wood veneer. Most of painted steel door frames are scratched and could be repainted. The coat hooks and shelving along the corridors are fair to good condition.

The corridors have vinyl composition tile (VCT) floors and are in fair to good condition. Approximately 3% of the tiles that are cracked and should be replaced. The floor on the second floor entry, has carpet tile and appears to be in good condition.

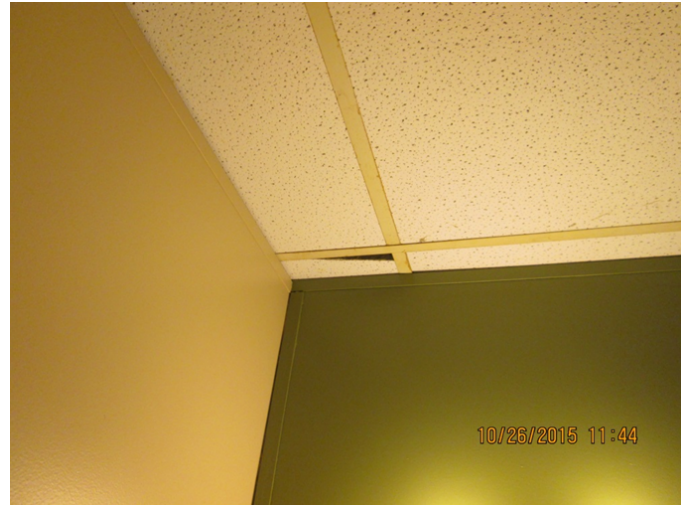
Most classrooms consists of walls that are painted insulated metal panels or CMU and are in good condition. Interior wood doors are generally in poor to fair condition with chipped and scratched finishes. The painted steel door frames in most rooms show scratches and wear. 95% of the classroom have 8" x 8" VAT (vinyl asbestos tile) floor finishes and are in fair condition. 95% of the offices and library have carpeting. The ceiling in most of the rooms are in fair condition and consist of 2'x4' acoustical ceiling panels. Approximate 5% the ceiling panels are stained or damaged. Several areas have newer ceiling tiles, but the ceiling grids appear to be much older. Approximately 15%

of the rooms have lay-in ceiling grids that are stained and discolored.

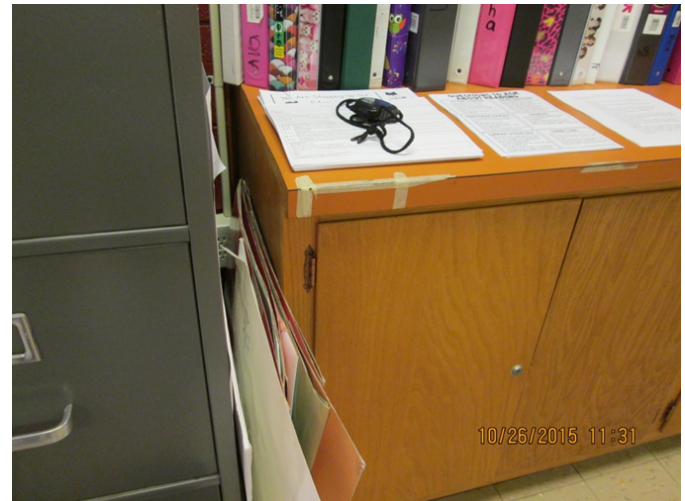
Casework in the classrooms are in fair to good conditions. Approximately 15% of the casework will require some cabinet door adjustment for alignment. Casework with sinks on plastic laminate countertop in most rooms are delaminating and should be replaced.

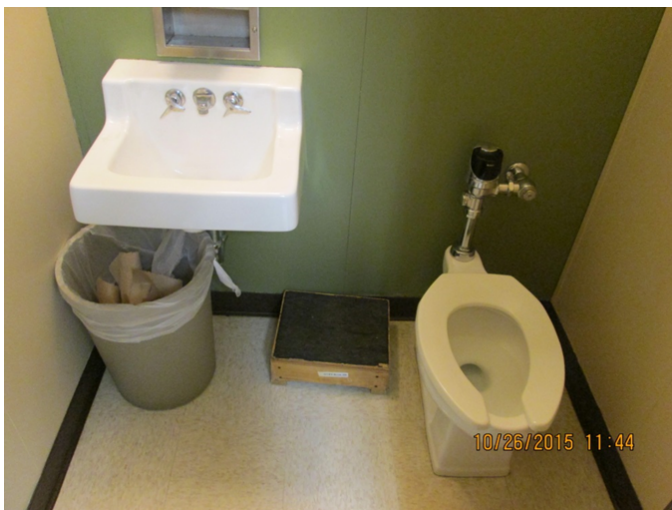
The building interior appears to be partially accessible to people with disabilities. Several of the toilet rooms are not arranged to be fully compliant with the ADA (American Disabilities Act) and with current standards for accessible design. One elevator is located centrally located and is near the main second floor entrance by Door #1.
