## DR. EDWARD G. DYER SCHOOL

### Building Information

This 2-story facility is located on a 9.78 acre lot. The building has an aggregate area of approximately 81,451 square feet. The facility was originally constructed in 1964 and building addition was done in 1967.

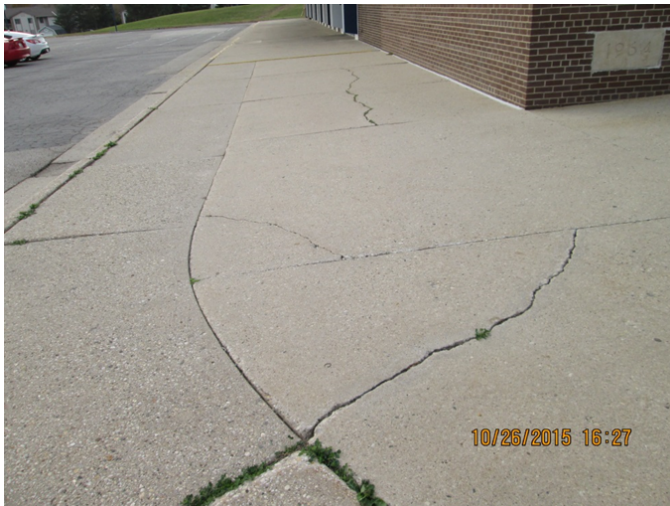
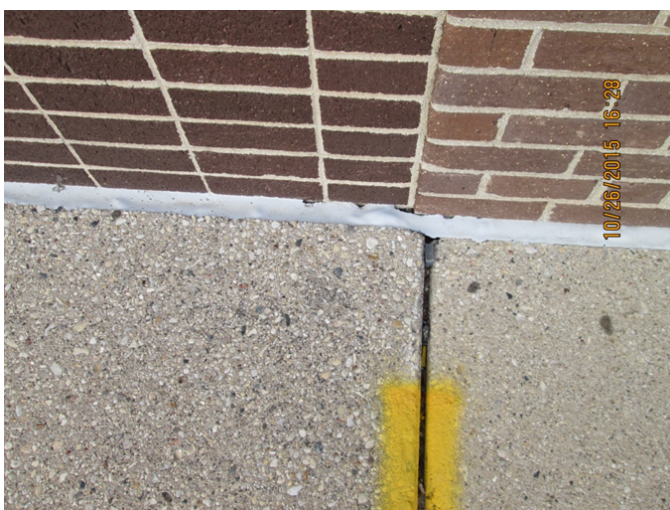
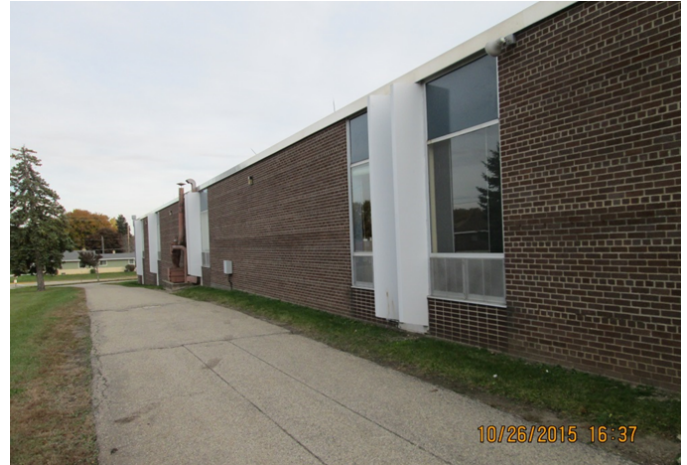
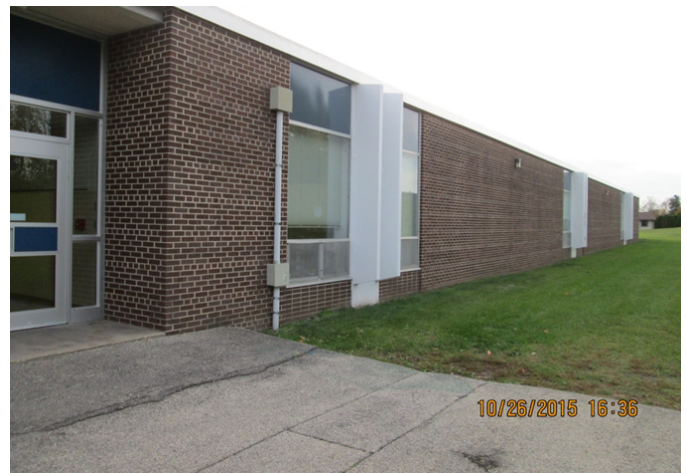
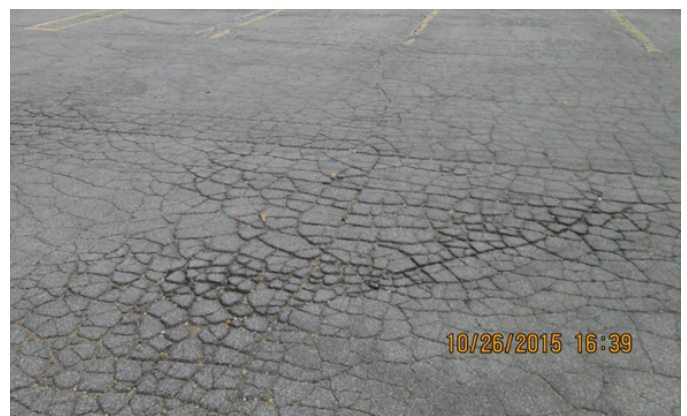
The concrete sidewalks are provided at the east and west sides of the building. They are in fair condition; however, southeast corner has a few concrete slabs that are cracked but still relatively level. The joint sealant between the concrete sidewalk and the building wall is deteriorating and will require replacement.

The asphalt driveway located on the east side of the building is poor condition with large areas of crocodile cracking and uneven surface. Asphalt repair, resurfacing and paint restriping will be required. The asphalt service drive / walkway located at the north side of the building is also in poor condition. Several uneven patch work and cracked edges are present. The pavement transition to the double Door #6 is not level. The asphalt parking lot also has larger areas of crocodile cracking which requires repair and paint restriping.

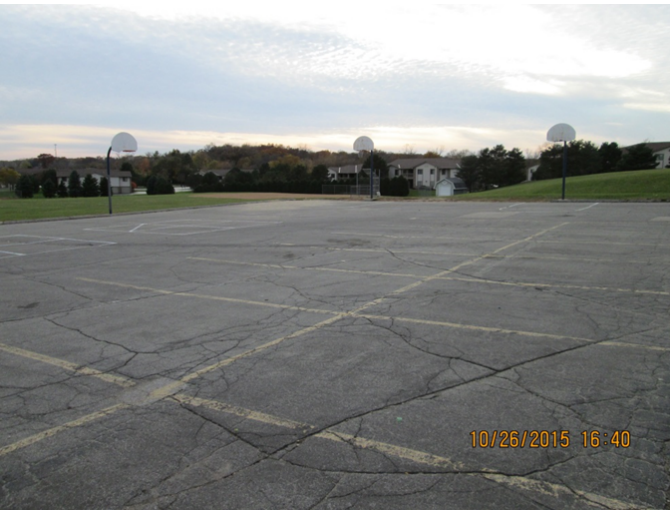
On-site parking spaces are provided on the southeast corner of the site. Handicap parking is located at the west end of the parking lot and at the end of the drop off drive. A faded cross walk paint striping connects the handicap parking onto the concrete sidewalk which leads to the front entrance of the building. The one-way asphalt drive on the north side of the building, also provides additional parking near the front entrance. The parking area extends into the asphalt play area. No physical barrier is provided to separate the play areas from the parking areas.

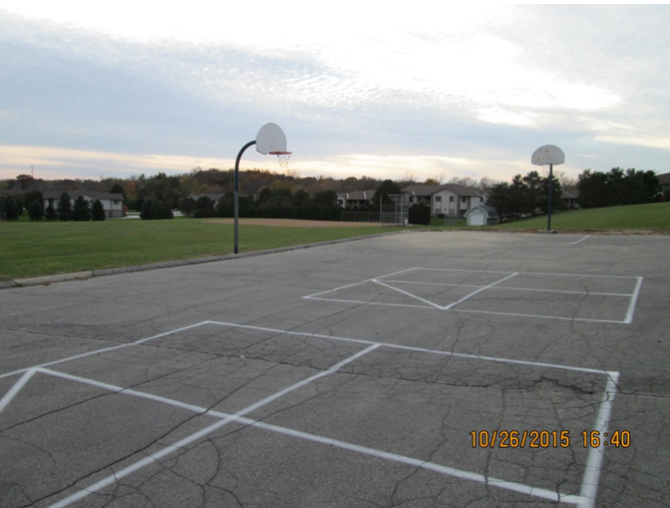
The asphalt surface play areas are in poor condition with large areas of crocodile cracking, uneven surfaces, missing paved areas and faded paint striping. The backboards for the basketball hoops are rusted.

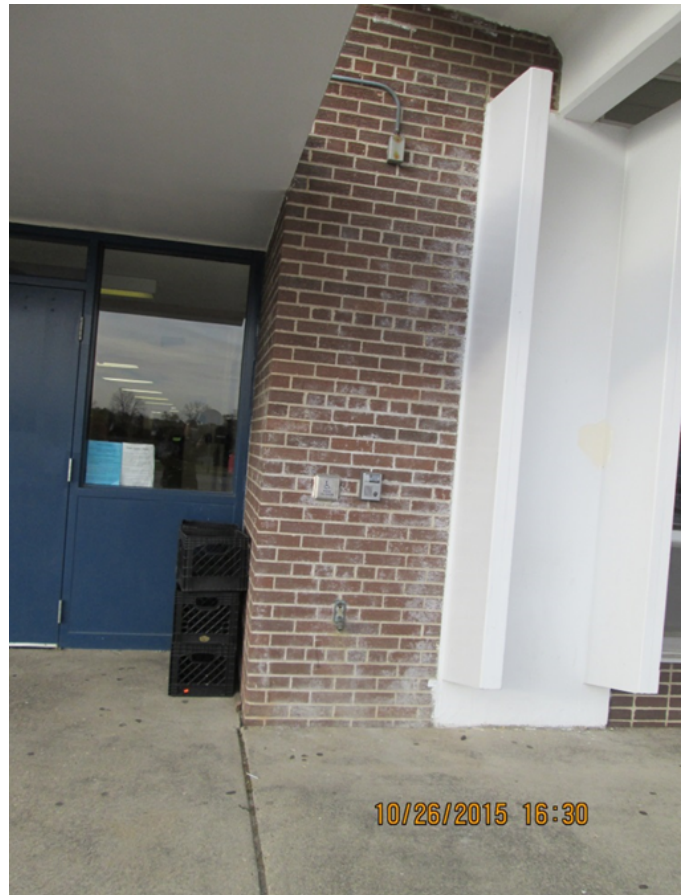
The building exterior cladding primarily consists of red face brick with painted precast concrete fins and capped with an aluminum coping. The bricks generally appear to be in fair condition, but have some stains on various areas of the building. Some efflorescence is evident at southwest corner adjacent to Door #3. Paint is peeling off on some of the precast concrete fins. The aluminum coping appears to be in good condition.

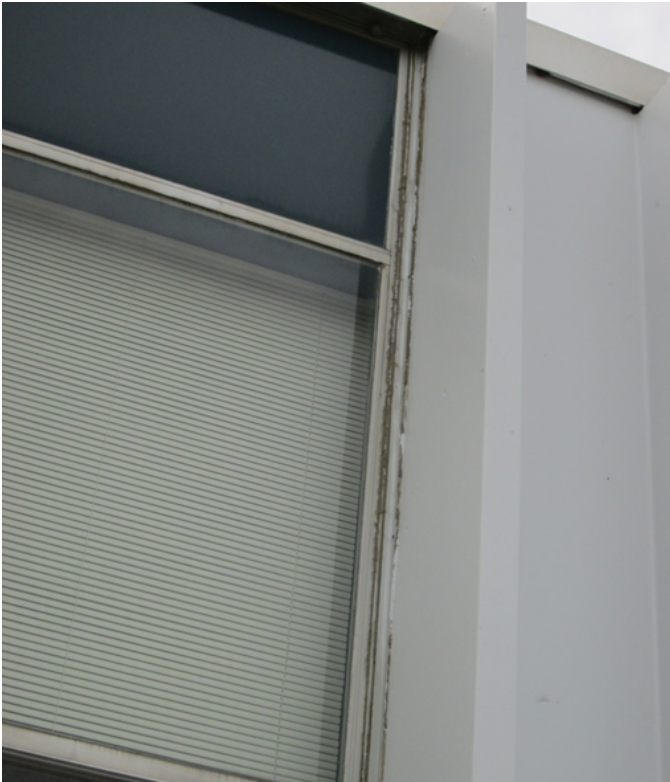
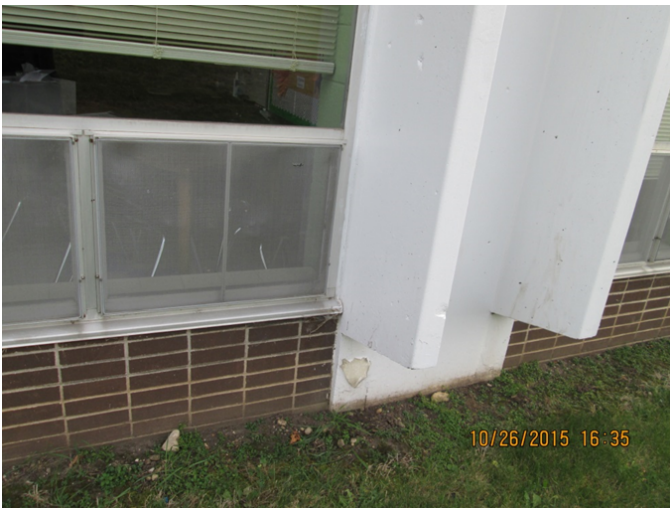
The aluminum window system consists of single pane glazing with operable awning windows and spandrel glass. They are in fair condition, but the sealant joints around the perimeter of each window are deteriorating and requires replacement. Some aluminum corrosion is visible on the interior surfaces of some windows. The screens on approximately 5% of the windows are damaged.

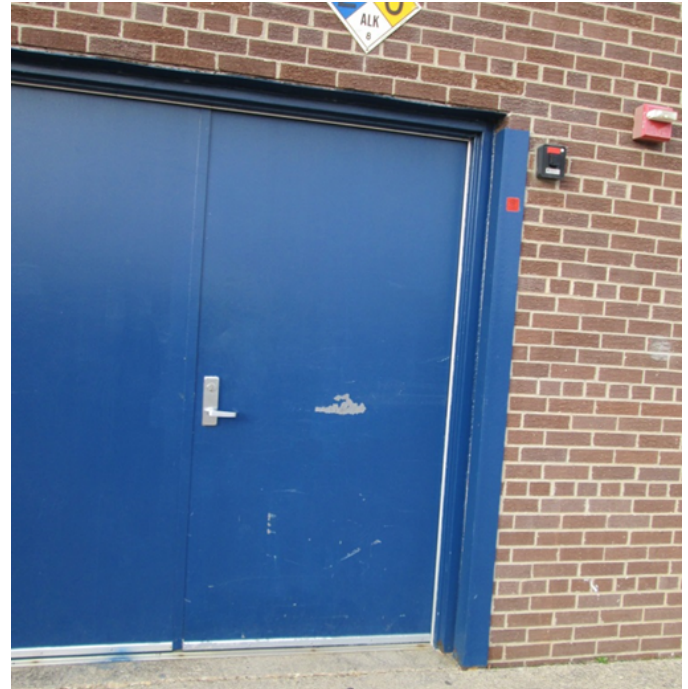
The building has mostly aluminum storefront exterior doors with insulated glass units and appear to be in good condition. There are two steel doors at the south side of the building that are in fair to poor condition, but will require some repair and refinishing. The doors and frames are faded, scratched, with surface rusting and dents. Weather stripping is also missing from Door #4.

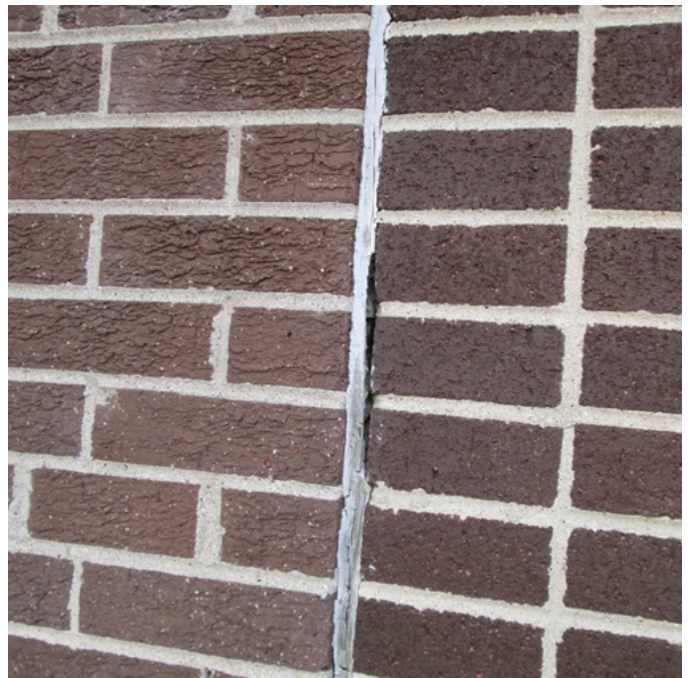
The brick mortar joints appear to be intact and in good condition. The sealant joints on the brick walls, window and door perimeter, and pavement are in poor condition or missing. These should be repaired or replace to prevent moisture infiltration and damage to the building.

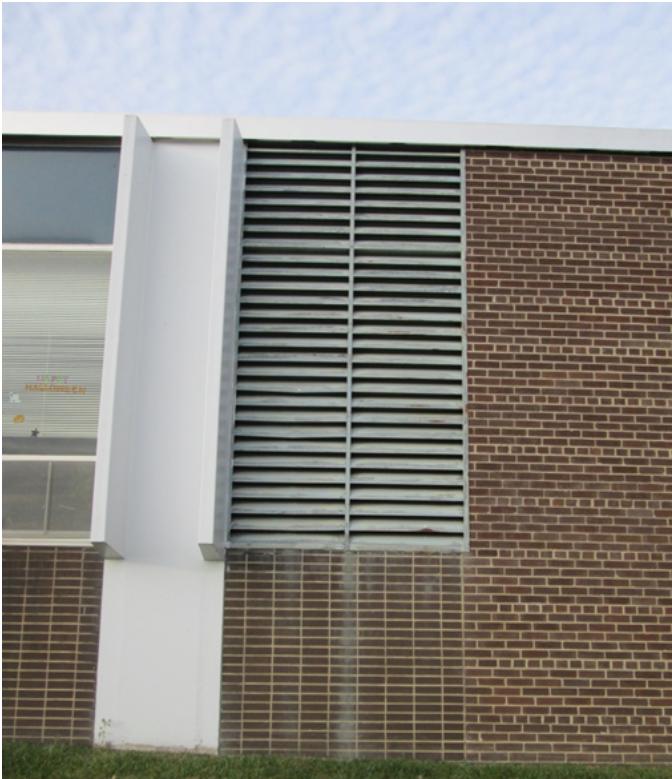
The finishes on miscellaneous pipe and exterior louvers are faded and/or rusted, causing rust stains to migrate onto the brick walls. Approximately of the 80% of the exterior light fixtures mounted on the building have discolored lens and housing.

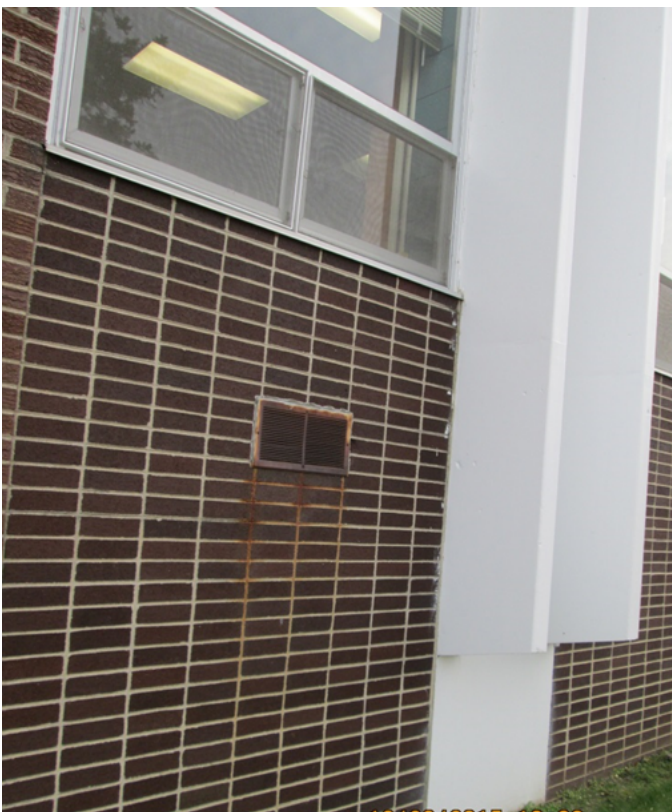
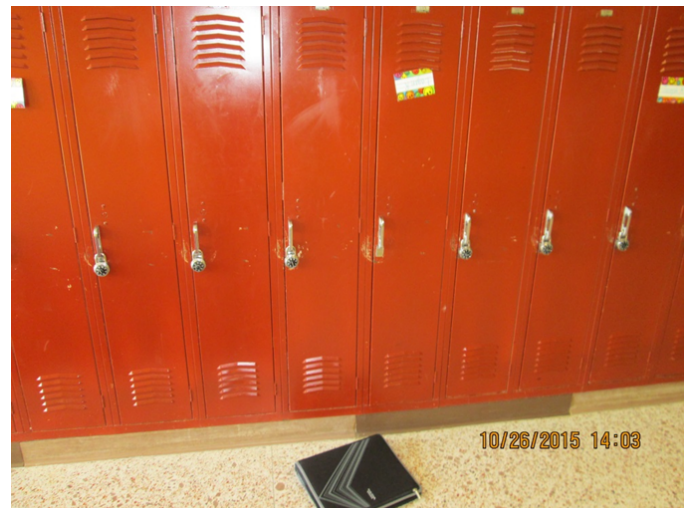
The acoustical ceiling panels in the corridors are in fair condition with approximately 5% requiring replacement due to water damage, physical damage and/or staining. The walls mostly consist of painted concrete masonry unit (CMU). Some corridor walls have a tile wainscot with approximately 5% of the tiles are damaged or missing. The paint on the walls is in fair to good condition, but is showing wear. Most of the doors are stained and varnished wood veneer and are in fair condition with some scratches, marks and dents. Approximately 10% of the doors are in poor condition and could be replaced. Most of painted steel door frames are scratched and could be repainted. The wall vinyl base is mismatched in a few areas of the corridors. Approximately 10% of the vinyl base could be replaced.

Lockers along the corridors are old, but in fair condition and could use repainting. Damage to the lockers appears to be limited only to scratched paint finish.

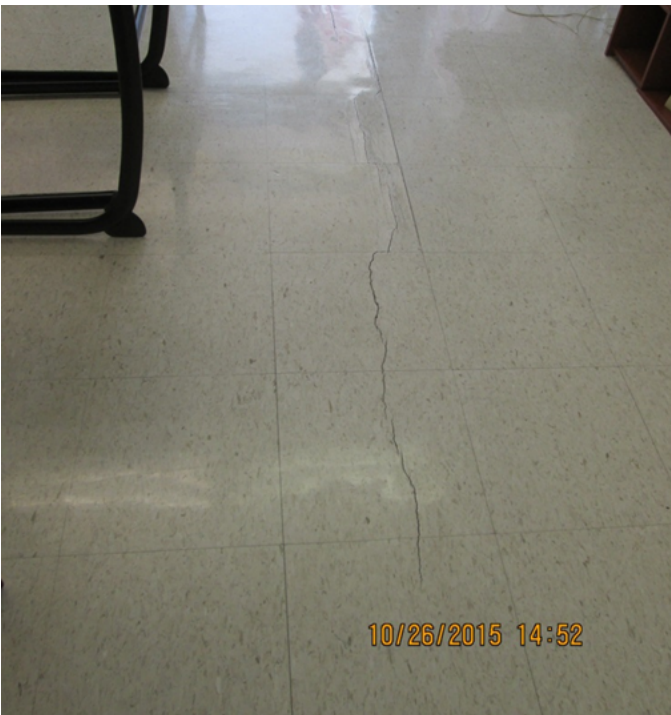
Most rooms have walls that are painted CMU and are in fair to good condition. Some painted walls are showing some wear and tear and could use some refinishing. The condition of the wood doors inside the rooms are generally in fair to good condition, however; the painted steel door frames in most rooms show scratches and wear. Most classrooms have VCT floor finishes and are in fair condition. There are a couple of classrooms with cracked VCT floors. There are also three classrooms and a storage room that have 8"x8" VAT flooring. The VAT floor in the classrooms appear to be in fair condition; however, the flooring in Storage 117A is delaminating and should be abate

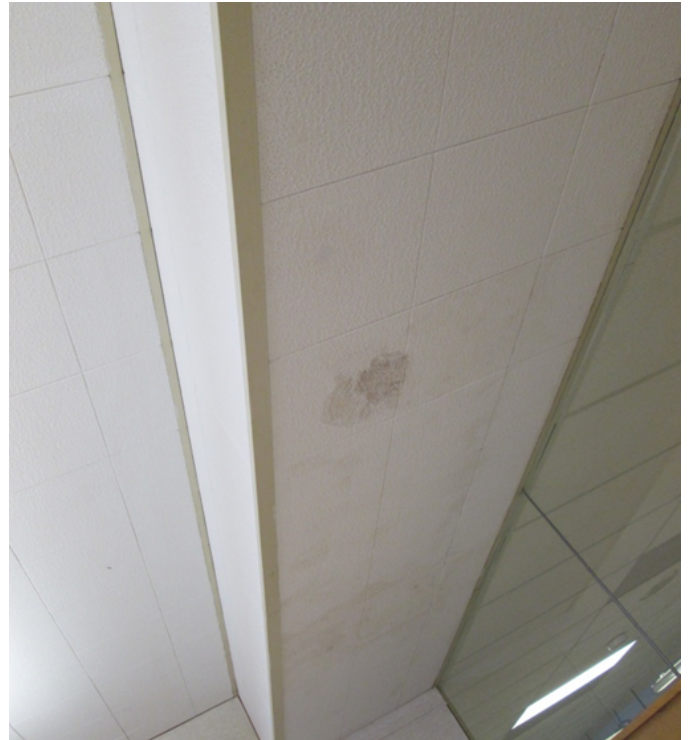
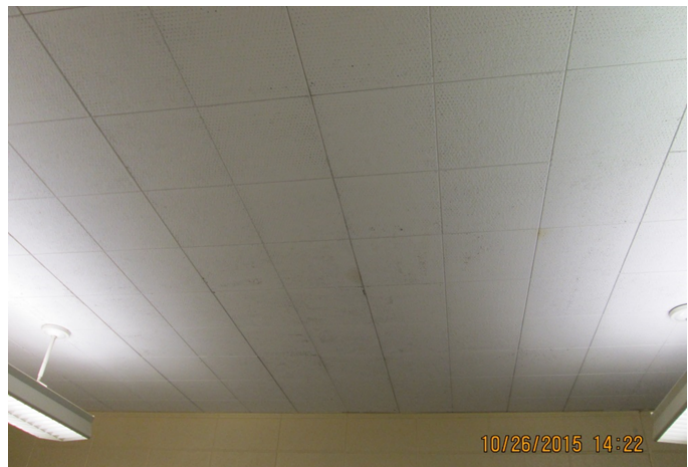
Most of the acoustical ceiling tiles and soffits in the classrooms are in poor to fair condition. Most of the classrooms have concealed spline ceiling system or directly adhered tiles to the ceiling substrate. It appears that some of the ceiling tiles were once painted to conceal old water stains and damage. However; the stains are reappearing in several areas. Approximately 25% of the rooms should have the ceiling tiles completely replaced with a new ceiling system.

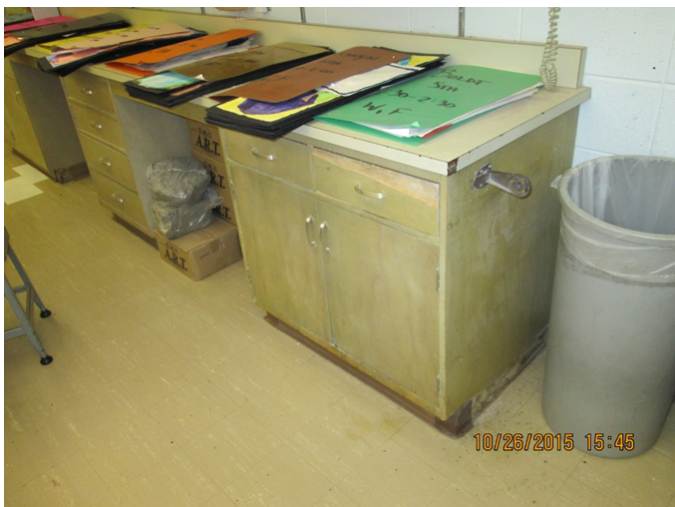
Most of the casework in the classrooms is in poor condition, with delaminating countertops, stained and damaged doors and cabinet bodies.

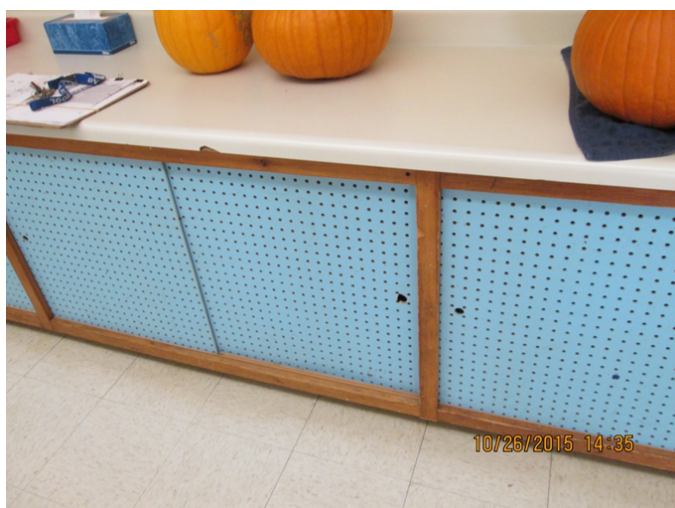
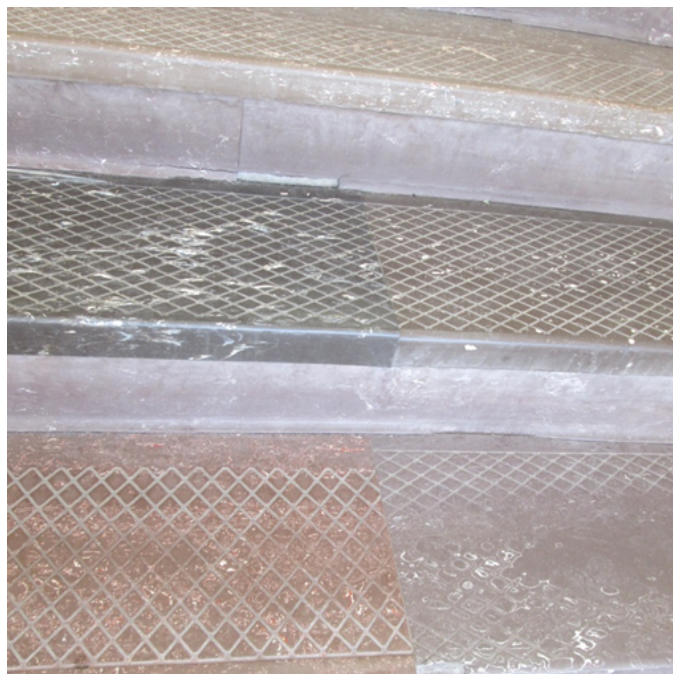
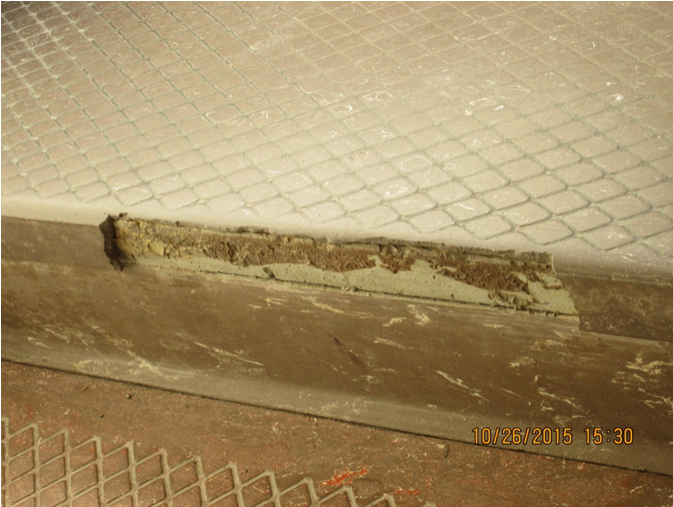
The resilient treads on Stairs #2 is in poor condition and should be repaired as soon as possible to avoid tripping. Aside from the mismatched colors, parts and pieces of the stair nosing is missing and vinyl on the risers are cracked and uneven.
