## NETTIE E. KARCHER SCHOOL

### Building Information

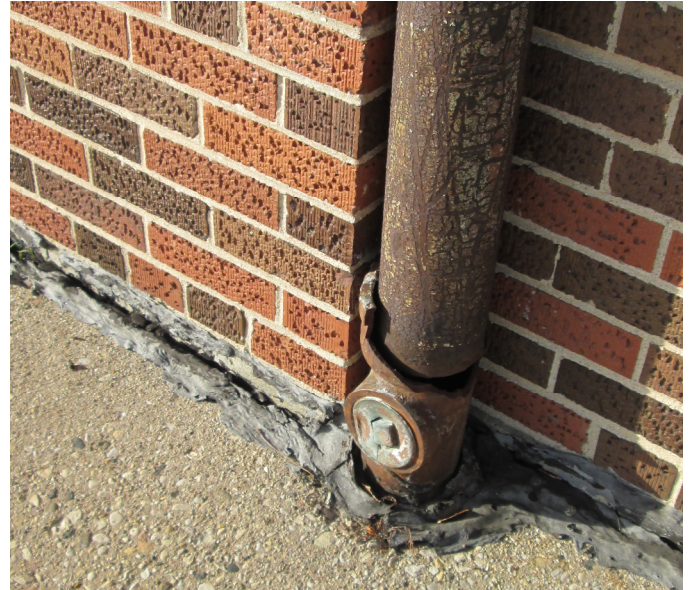
The sidewalks and concrete paved areas around the site are in poor deteriorating condition. Although the front sidewalk is in fair condition, the other concrete paved areas have large cracks, uneven walking surfaces, spalled and missing concrete. Concrete curb cuts for wheel chair access are deteriorating. The joint sealant between the building wall and the concrete pavement is missing or deteriorated.

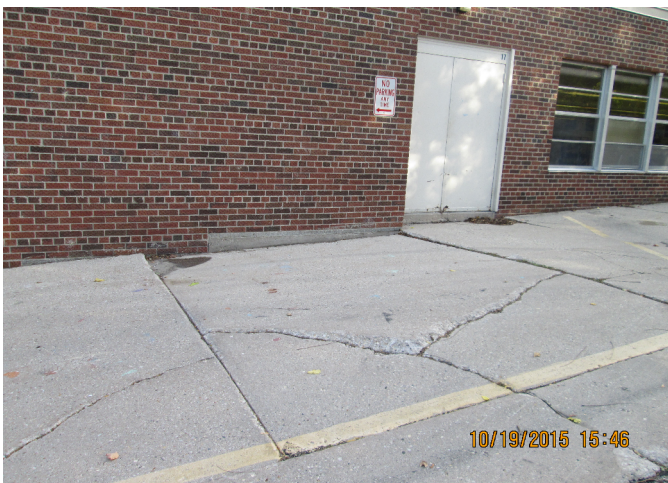
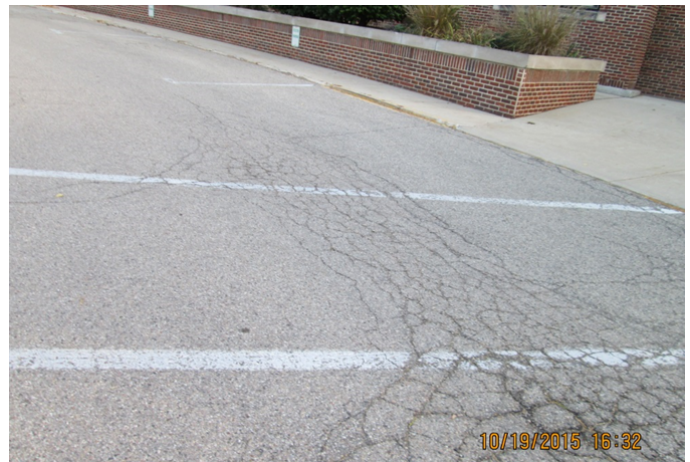
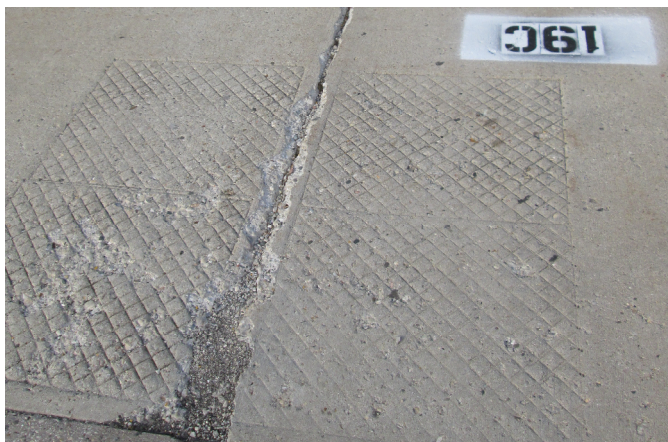
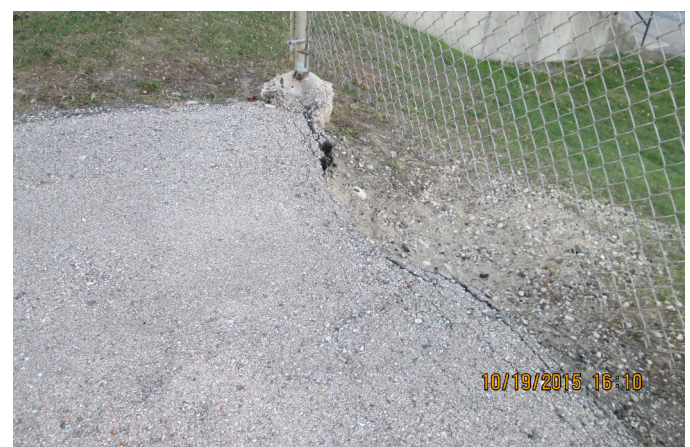
The asphalt driveway is in poor condition with large areas of crocodile cracking. Asphalt repair, resurfacing and paint stripping will be required. The asphalt paving at the south parking lot is eroding along the fence line. There is a 12" to 18" gap between the bottom of the wire mesh and the pavement in several areas.

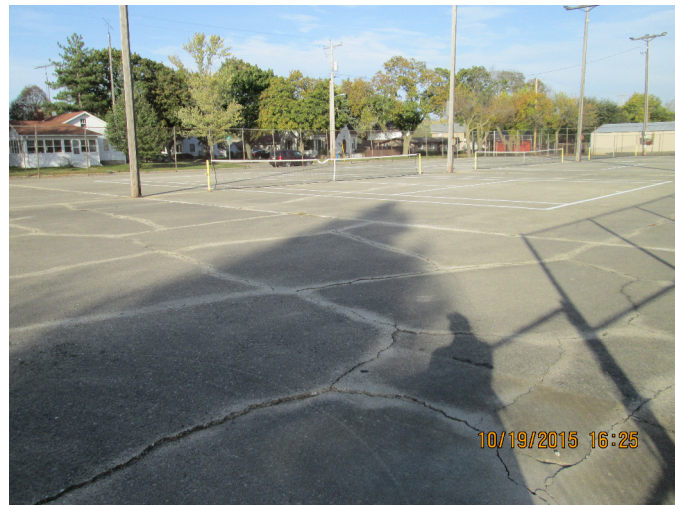
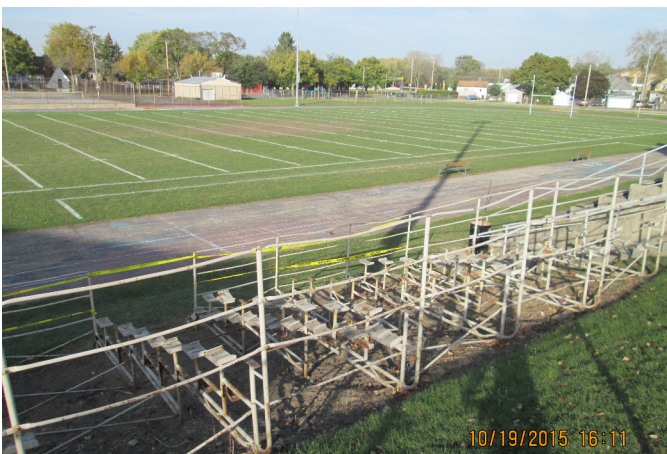
The track is in poor condition with cracked and uneven surfaces and worn out paint stripes. The football field is in fair condition; however, the bleachers are in poor condition with all the benches missing and rusted and bent steel framework. The tennis courts are in poor condition with large cracks and uneven surfaces. The wire mesh fencing is rusted and is bent in several locations.

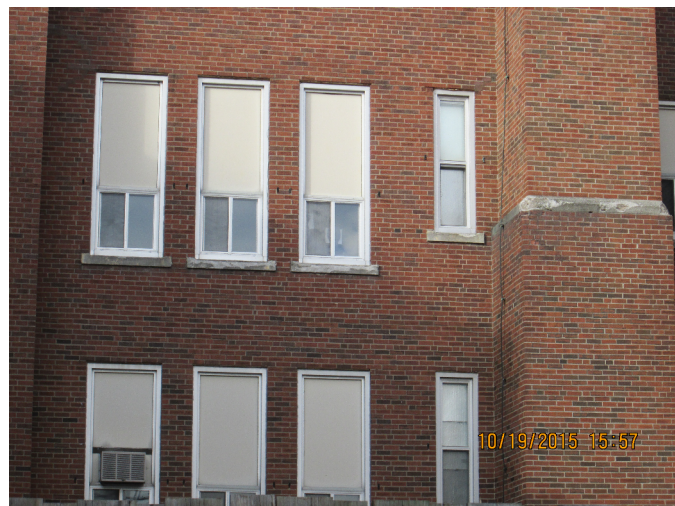
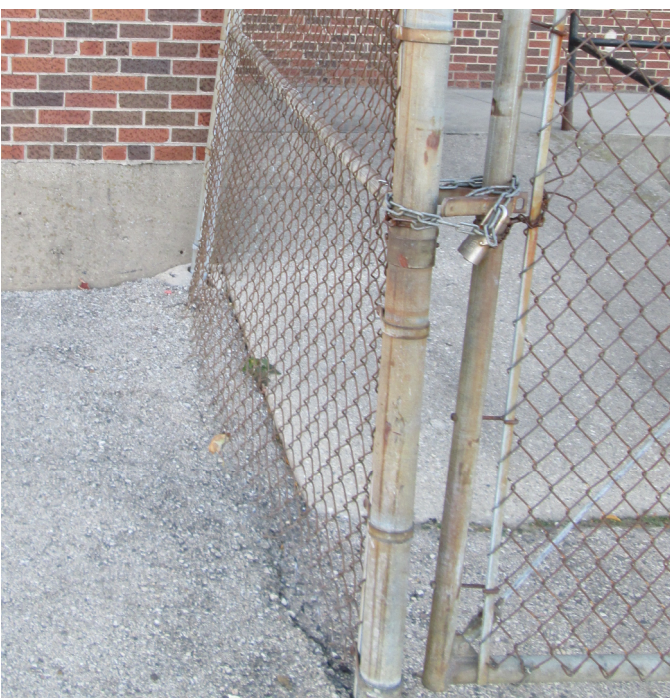
The building exterior cladding primarily consists of red face brick with lime stone sills and banding. The bricks generally appear to be in good with some rust stains on various areas of the building. The lime stone sills are heavy stained and approximately 15% of the limestone sills and caps are heavily deteriorated.

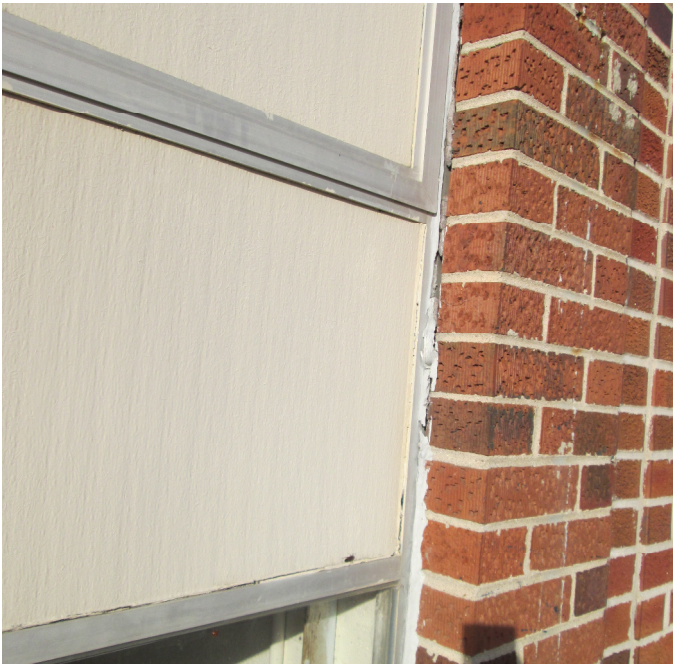
The building addition located at the southwest corner has an aluminum curtain wall system that is in poor condition. The wall system has uninsulated single glazing and the sealant joints are missing or deteriorated. Some of the window panels appeared to have been blocked off with insulation in an effort to conserve energy.

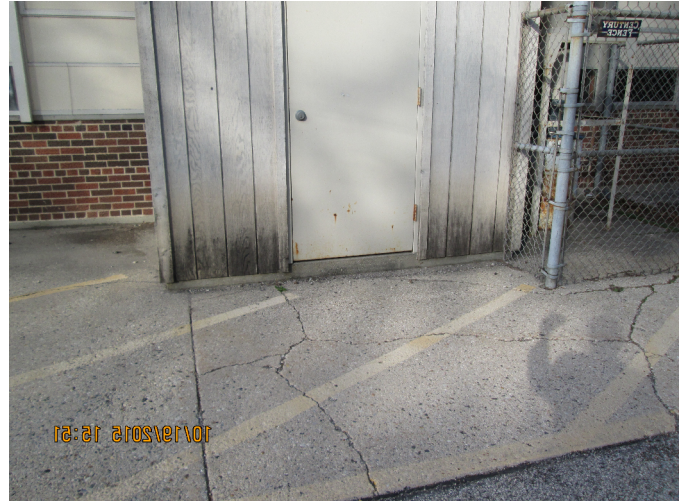
There is wood frame structure addition located on the southwest corner just of the Receiving area. The wood siding, soffit and fascia boards are badly stained and discolored. It appears that some of the boards are starting to rot.

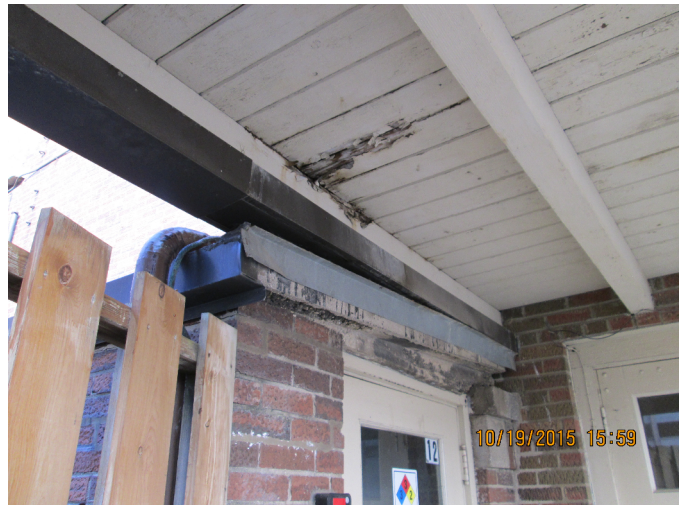
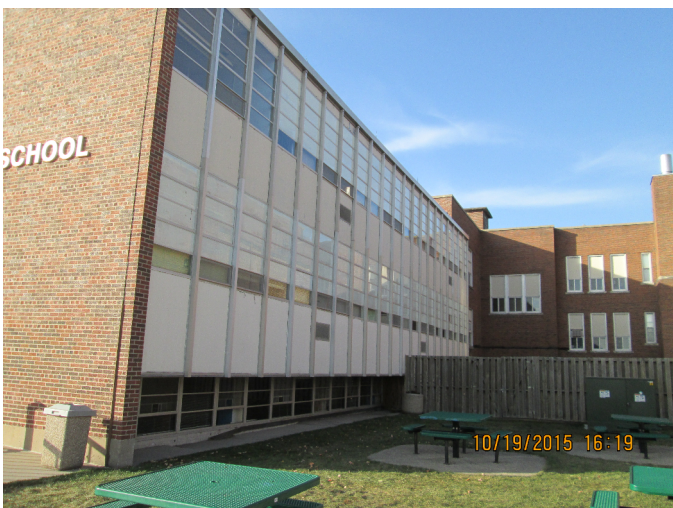
There is a wood canopy supported by steel posts located at the south side of the building by Door #12. The paint on the wood canopy is stained and peeling. Some boards appear to be rotted. The painted wood doors under the canopy are also stained and show some damage.

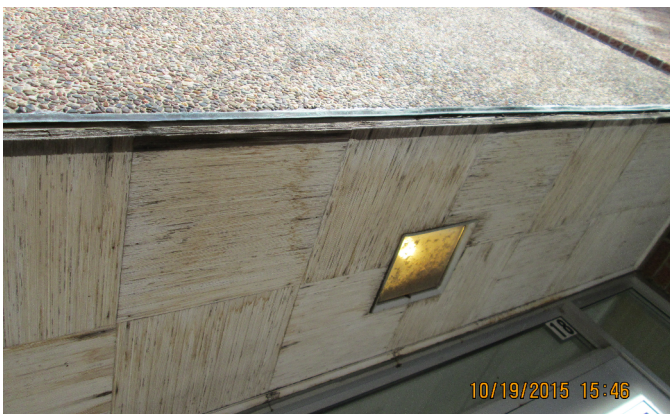
The entrance soffit at northwest corner located at Door #18 appears to be painted wood. The soffit is baldy stained and the light fixture is discolored and filled with dirt and debris.

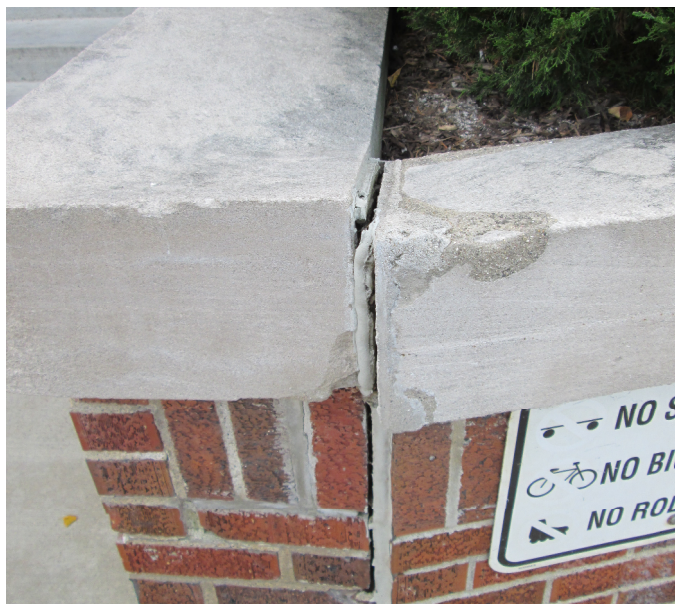
Most of the brick mortar joints appear to be in good condition, except at the front entry planter wall.

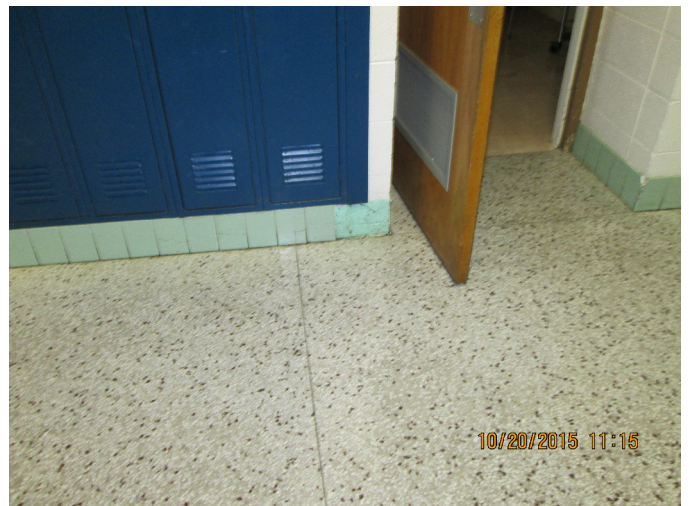
The acoustical ceiling panels in the corridors are in poor to fair condition with approximately 15% requiring replacement due to water damage, physical damage and/or staining. The walls mostly consist of painted plaster and painted concrete masonry unit (CMU). Some corridor walls have a tile wainscot with approximately 8% of the tiles are damaged or missing. The paint on the walls is in fair condition, but is showing wear. Most of the doors are stained and varnished oak veneer and are in fair condition with some scratches, marks and dents. Approximately 5% of the doors are in poor condition and could be replaced. Most of painted steel door frames are scratched and could be repainted.

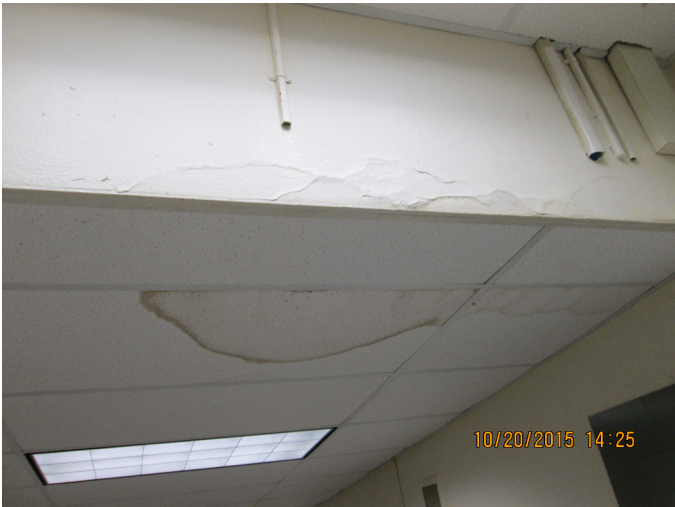
Some areas have gypsum board soffits that are cracked, stained, and/or water damaged.

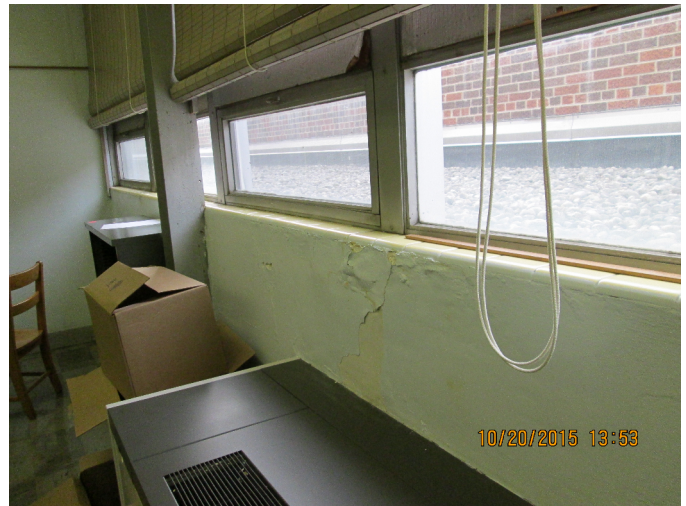
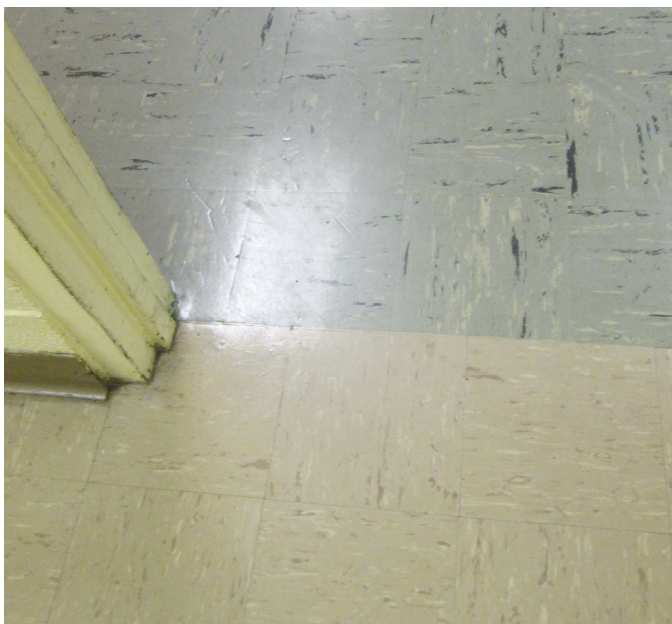
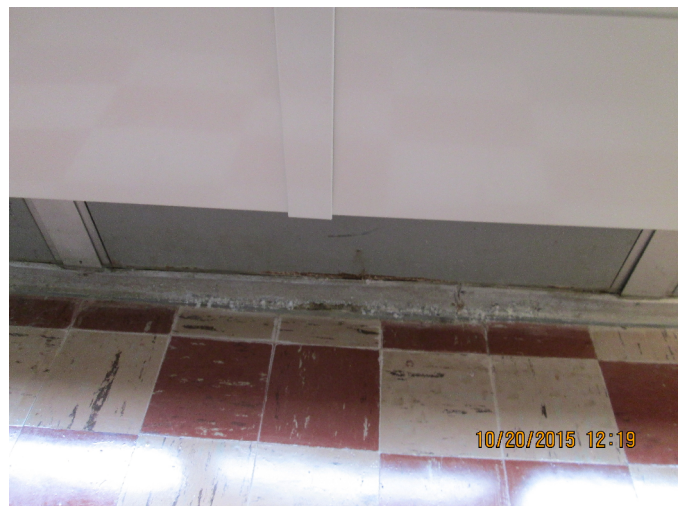
Most rooms have walls that are painted plaster or CMU and are in fair condition, with stained and/or discolored walls. Interior wood doors are generally in fair to good condition, however; the painted steel door frames in most rooms show scratches and wear. Most classrooms have VCT floor or VAT (vinyl asbestos tile) finishes and are in fair condition. 60% of the classrooms have 8" x 8" VAT flooring.

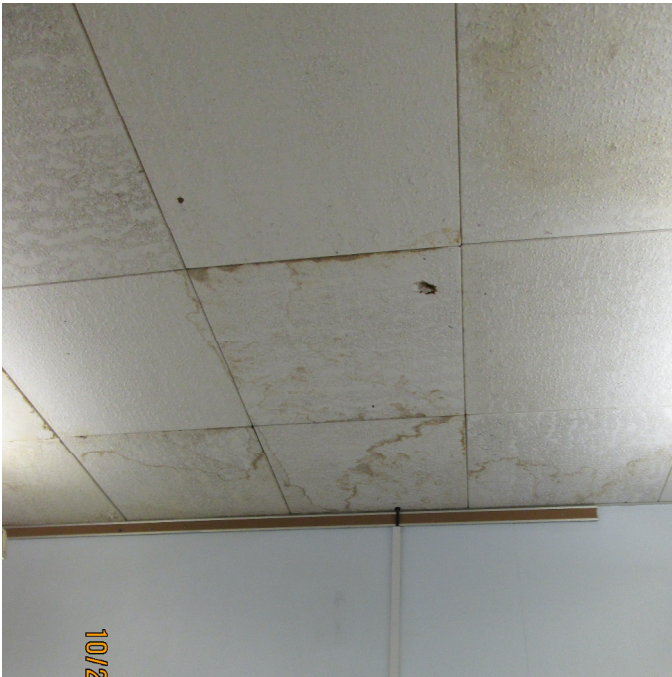
Some classrooms on the second and third floors have wood flooring that are in fair condition, but are creaky and uneven. High use rooms that are carpeted are in poor to fair condition, with wear patterns leading from the room door to main destination areas. Most (approximately 85%) of the acoustical ceiling tiles in the classrooms are in poor condition and should be replaced. They are badly stained, damaged, and/or sagging.

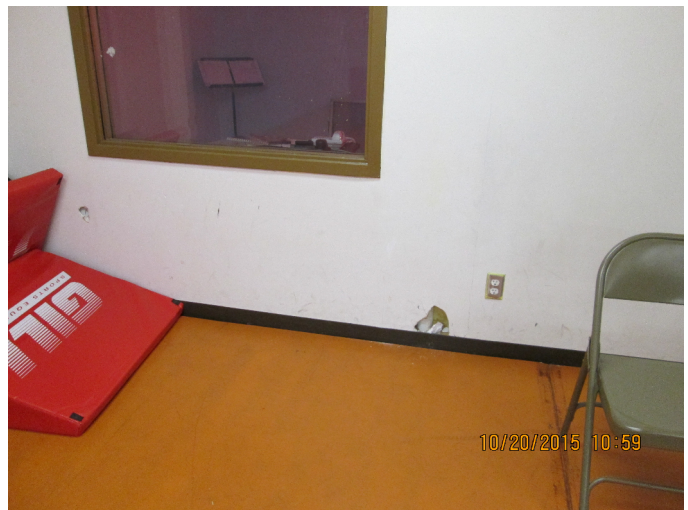
The Wrestling Training room 180 on the second floor is in poor condition with damaged plaster walls and ceiling tiles.

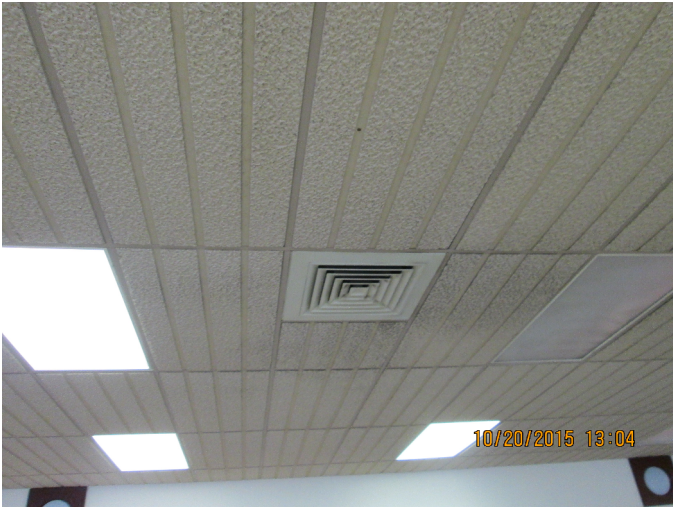
The library is in fair condition, but has stained carpeting with some seams fraying. The casework appears to be in fair condition. The ceiling tiles appears newer than most in the building, but are discolored and stained in some areas.
