## WALLER ELEMENTARY SCHOOL

### OVERVIEW

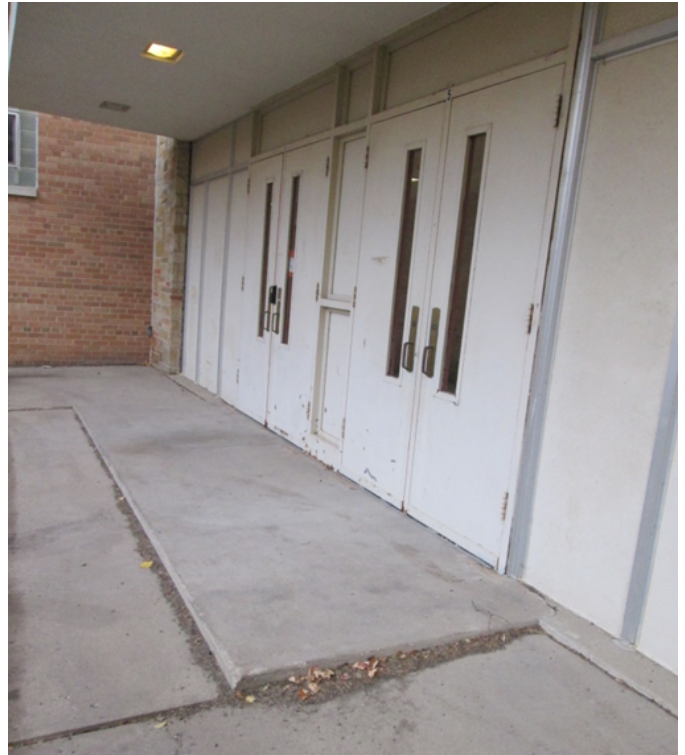
The sidewalks and concrete paved areas around the site are in fair to poor deteriorating condition. The concrete sidewalk leading to the main entry is in fair condition, however; there are a couple of areas where the sidewalk slab is not even with the adjacent slab. The sidewalks along the street have several locations where the concrete slabs are cracked and uneven. The concrete slabs located outside of Doors 4, 5 and 7 have cracked and settled creating in a tripping hazard.

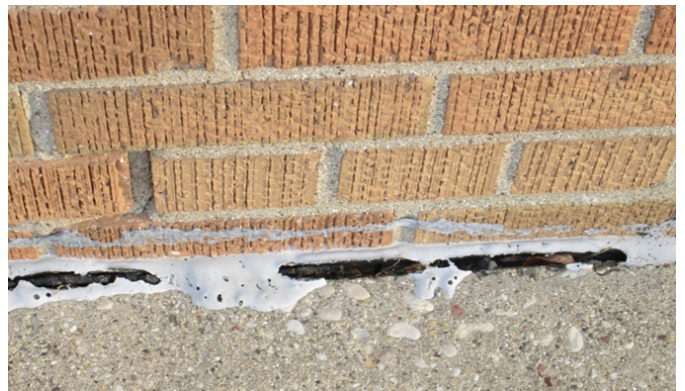
The joint sealant between the building wall and the concrete pavement is missing or deteriorated.

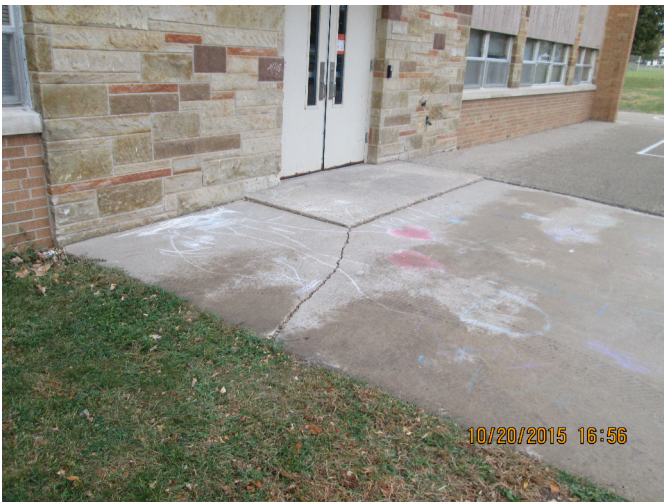
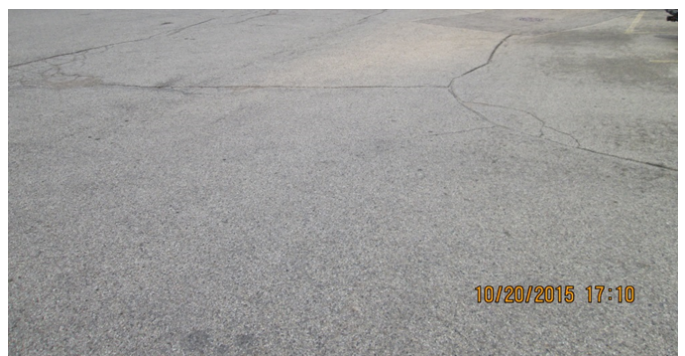
The asphalt parking lot is in poor to fair condition with some areas showing crocodile cracking. Asphalt repair, resurfacing and paint stripping will be required.

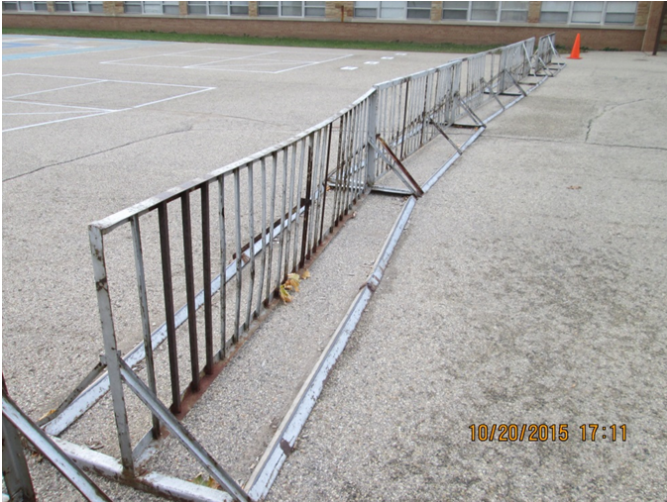
An asphalt parking lot, located on the east side of the property, is limited. The main public entry to the building is located on the second floor. The student primarily enter on the first floor level adjacent to the parking lot. Limited handicap parking is located on the first floor, adjacent to door 1. Rusty bicycle racks are being used to separate the parking area from the playground areas.

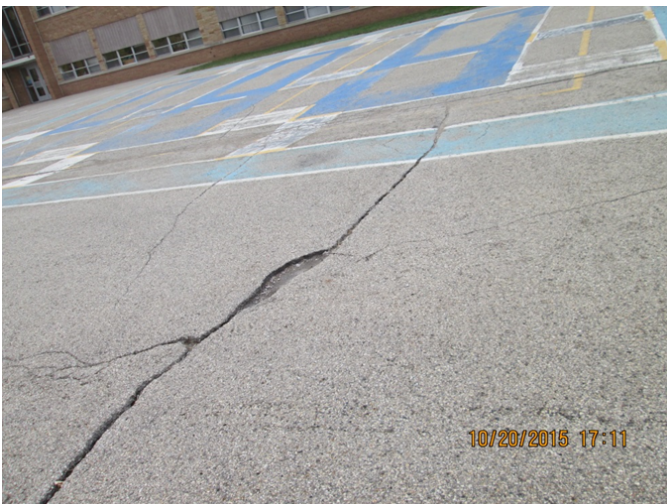
There are three baseball diamonds that appear in good condition, aside for patches of areas where the grass is worn down. The asphalt playground is in poor condition with large cracks, crocodile cracks and patches of missing pavement. The paint on the play areas are faded and some basketball hoops are damaged. The slides and monkey bar equipment appears to be in good condition. Wood chips need to be added or rearranged to provide an even playing surface.

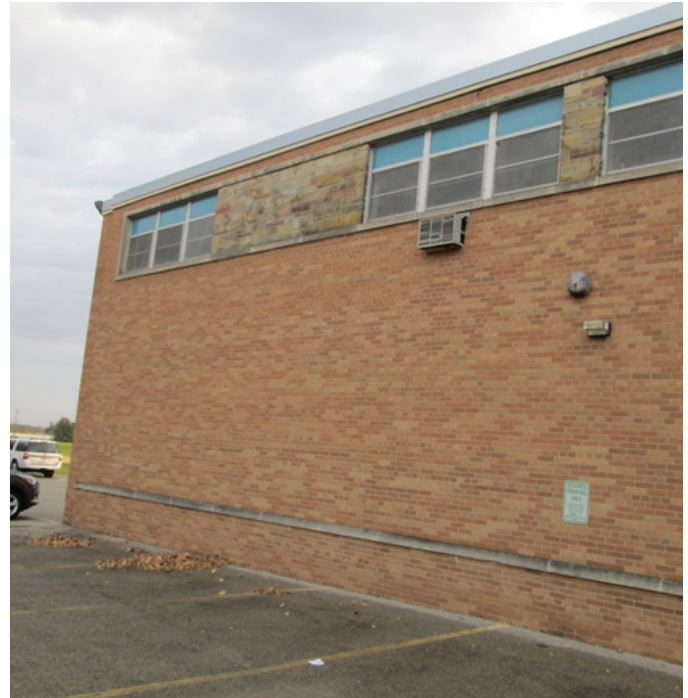
The building exterior cladding primarily consists of face brick with accent stone pillars and limestone window sills. The bricks generally appear to be in good with some rust stains on various areas of the building. The lime stone sills have some staining, but appears to be mostly intact.

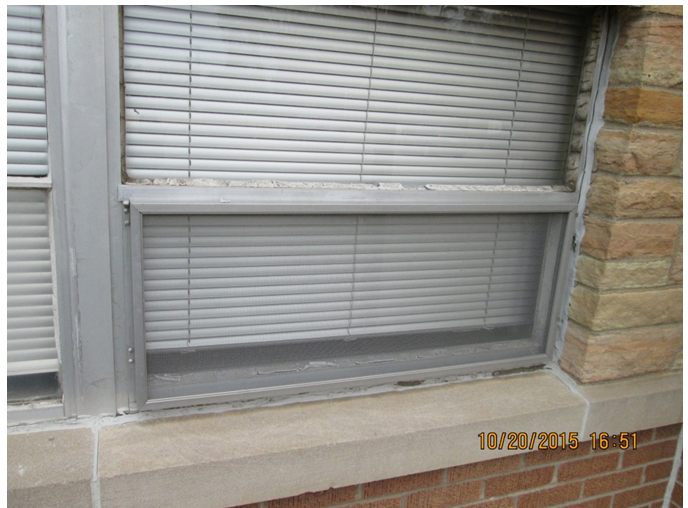
Most of the brick and stone mortar joints appear to be in good condition. However; the sealant joints on the brick walls, windows and door perimeter, and pavement are in poor condition or missing.

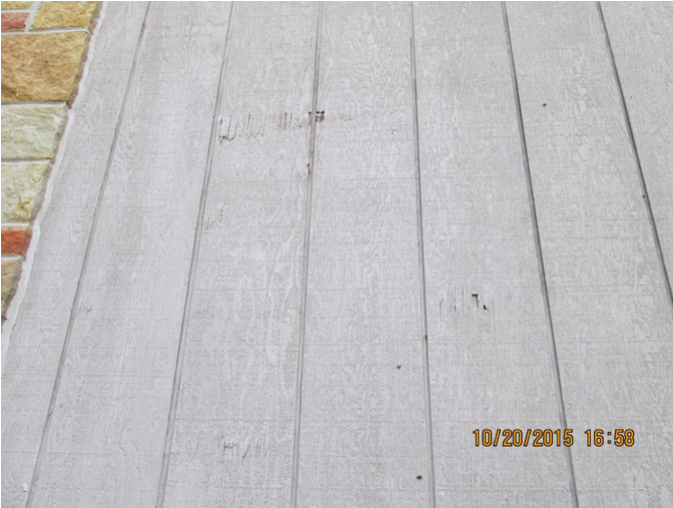
Single glass pane aluminum windows with operable awnings and screen are not energy efficient and are showing wear. Approximately 3% of the glazing is broken or cracked and 100% of the window caulking will require replacement. Wood paneling was installed over the upper portion of the window assembly, in an apparent effort to conserve energy. Some of the wood panels are damaged, peeling, and discolored.

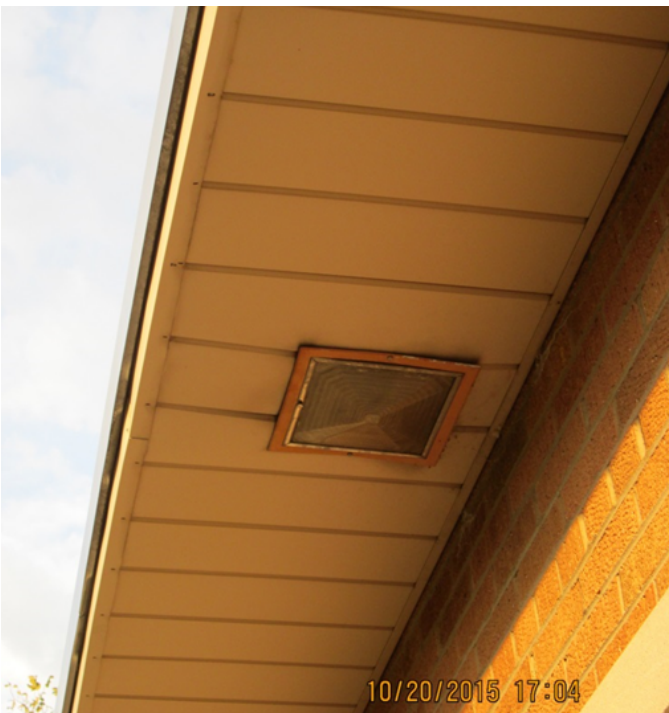
The aluminum soffit around the building appears to be in fair to good condition. However, some light fixtures are not properly secured and are discolored.

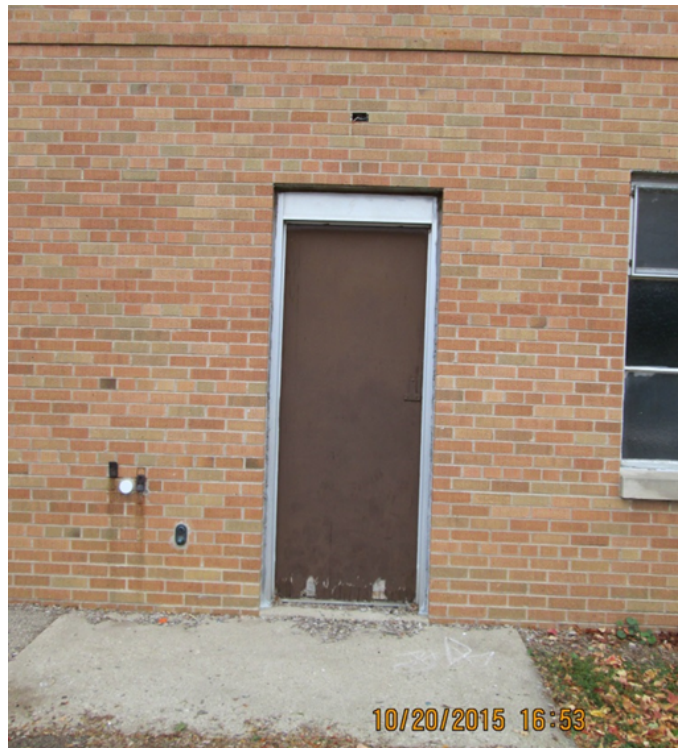
The aluminum storefront doors at the building entrances appear to be in fair to good condition. However, the painted steel doors have a lot of scratches and rust stains. There is a deteriorating exterior wood door located in Closet 122, adjacent to the Girls Toilet Room 123. The electrical box located above the door, from a removed light fixture was left open to the elements.

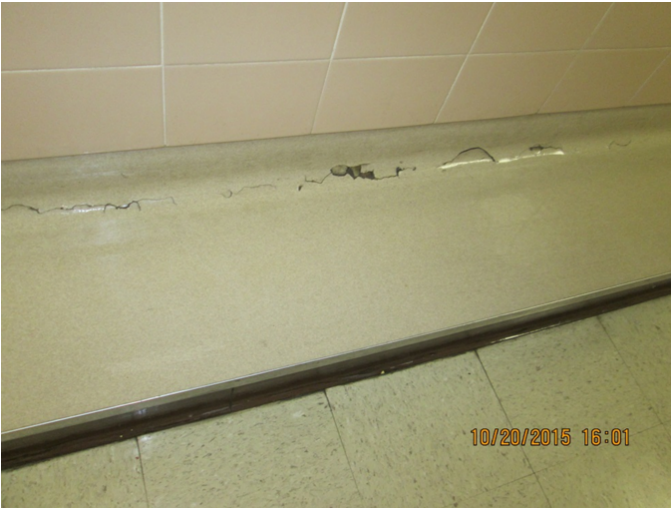
The coat hooks and painted shelving along the corridors are in fair condition and could use repainting. The sheet vinyl or linoleum liner for the boot shelf is damaged in some areas.

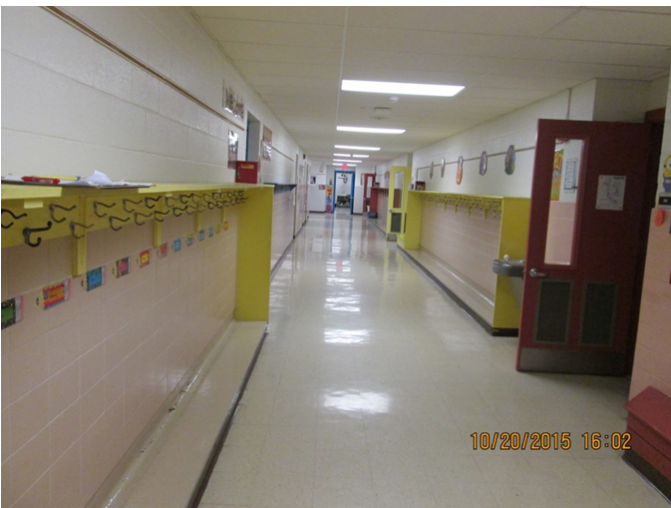
The corridors have mostly vinyl composition tile (VCT) floors and are in fair to good condition.

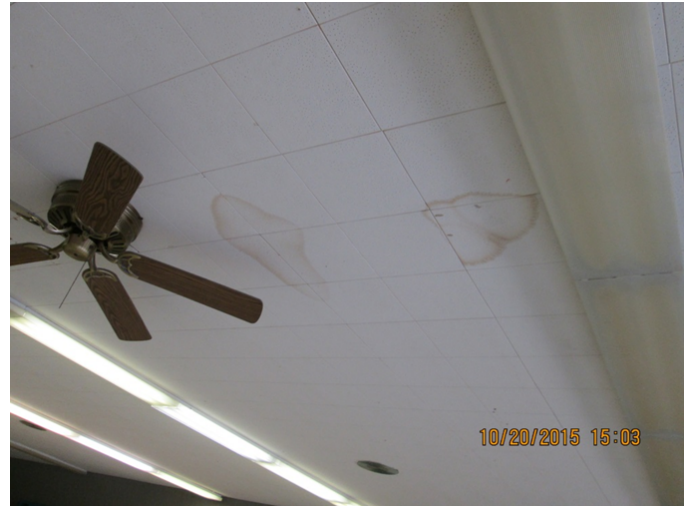
the ceilings in approximately 90% of the classrooms are 12"x12" conceal spline acoustical ceilings that show wear, water stains, and physical damage. Some areas of the ceilings appear to have been previously painted to conceal previous water stains, but are still showing through. Approximately 20% of the light fixtures in the classrooms are discolored.

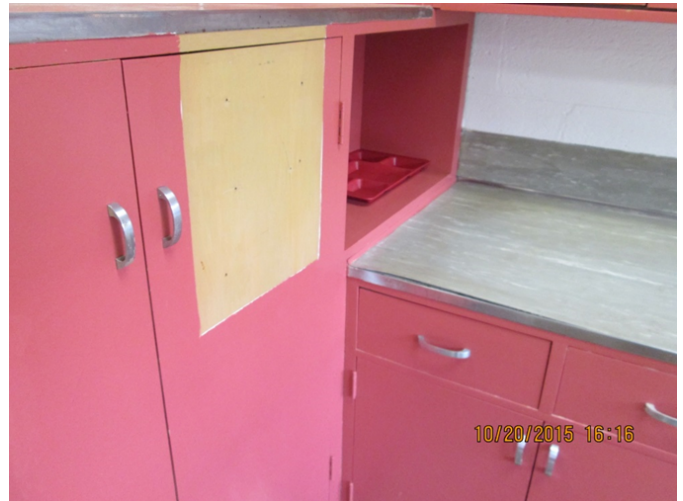
Approximately 95% classrooms have casework, and they are in poor condition. The paint is scratched and uneven, the hardware is stained, and most of the countertops have linoleum which are worn, chipped or delaminating.

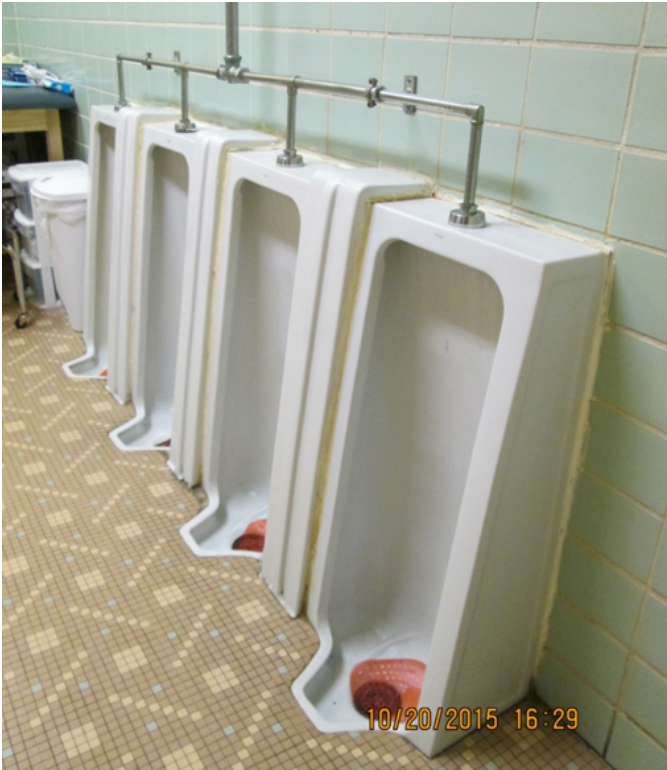
The Boy's and Girl's Toilet rooms are not fully compliant with today's accessibility standards. Approximately, 5% for the ceramic tile walls and porcelain tile floors show some damage or staining. The sealant joints around the urinals are in poor condition with stained, cracked and peeling caulking. There are numerous unpatched holes on the ceramic tile walls from removed fixture and toilet accessories.

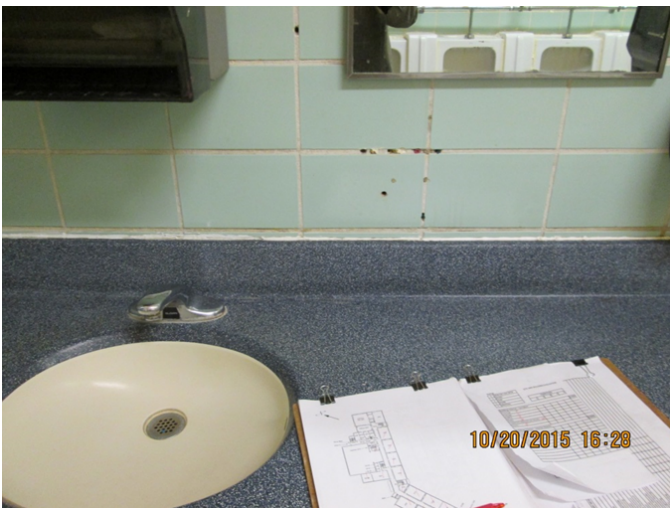
The building interior appears to be mostly accessible to people with disabilities. However; several of the toilet rooms are not arranged to be compliant with the ADA (American Disabilities Act) and with current standards for accessible design. There is one elevator centrally located in the building.
