## WINKLER ELEMENTARY SCHOOL

### Building Information

This one story facility is located on a 10 acre lot on the outskirts of the city. The building has an area of approximately 26,000 square feet. and was constructed in 1999.

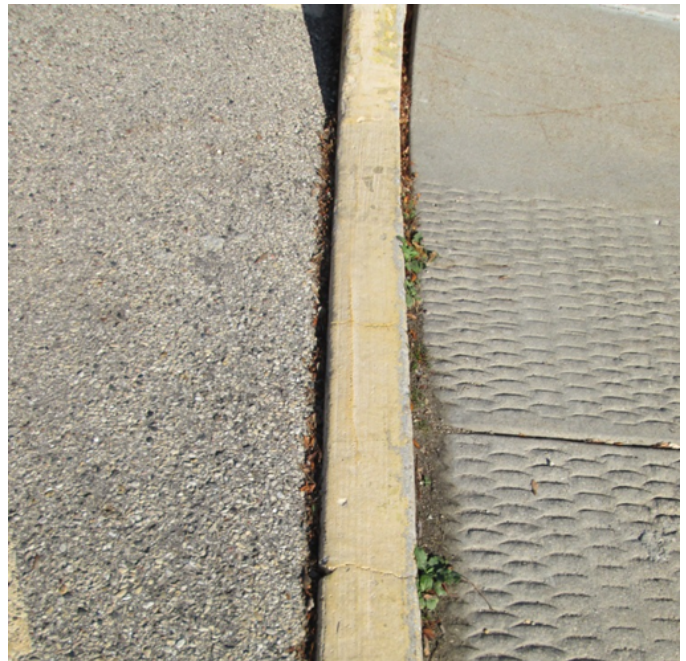
On-site parking is located on west side of the building and a drop off drive way encircles the parking lot. Two handicap parking spaces are located near the cross walk towards the building entry. However, the curb cut has a curb that is not flushed with asphalt drive not the concrete walk. Either the curb needs to be ground down or the adjacent surfaces raised, in order to comply with the ADA (American Disabilities Act) accessibility requirements.

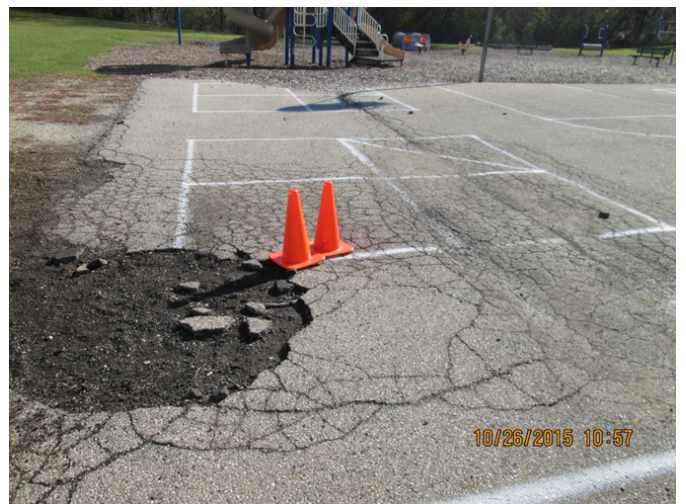
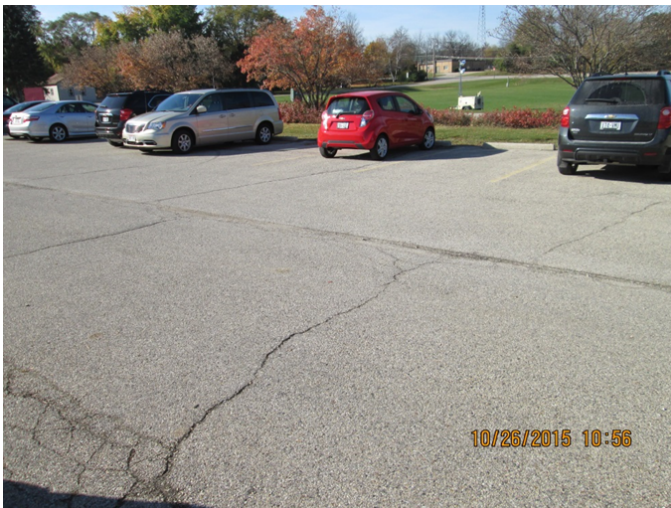
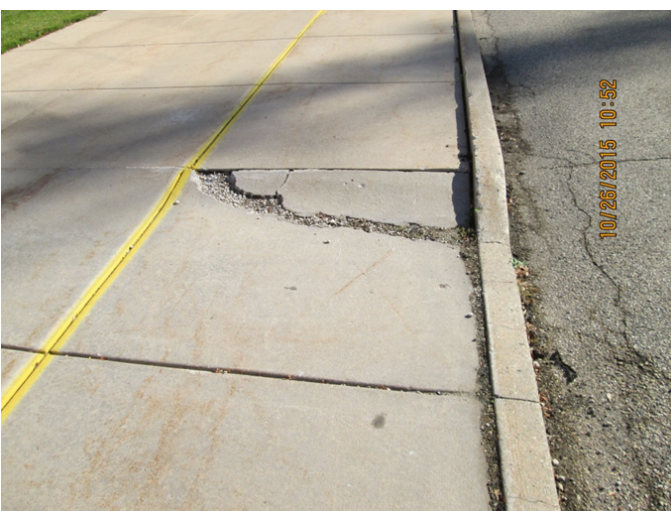
The asphalt play areas are poor condition with large areas of crocodile cracking, uneven and missing pavement surfaces. The paint stripes are also worn out. The playground equipment on the wood chips appears to be in good condition.

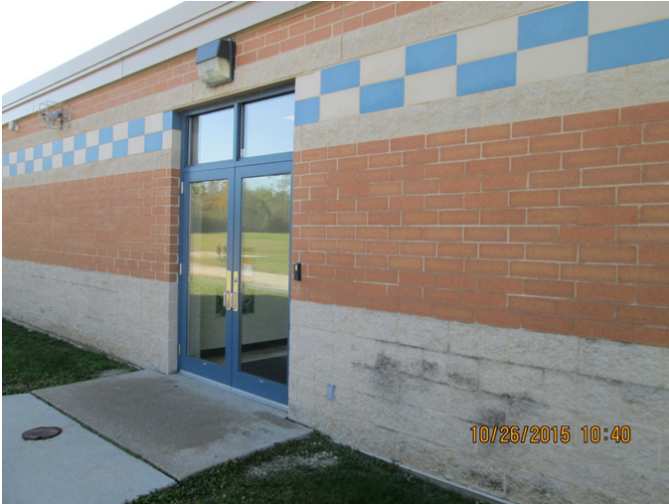
The building exterior cladding primarily consists of red face brick and colored concrete masonry unit (CMU) banding with a large aluminum fascia and roof coping. The bricks, aluminum fascia and coping appear to be generally in good condition. The light colored CMU wall, however; have dark stains on various areas of the building.

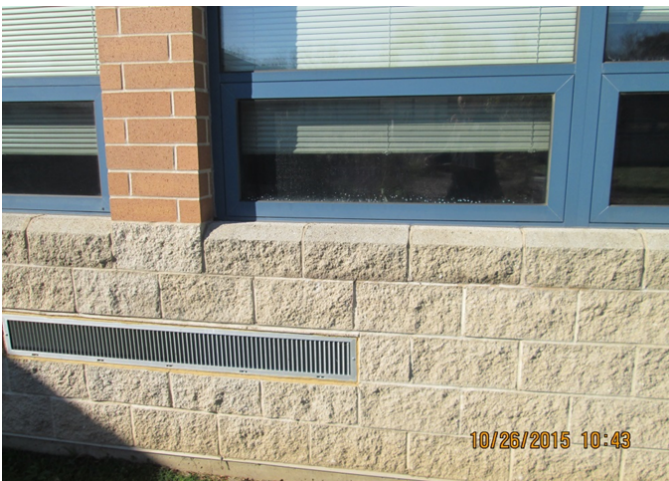
The aluminum storefront entry doors appear to be in good condition. The aluminum window system has insulated glass units with operable awning window units. The window system appears to be in good condition except for the seals appear to be broken on a couple of fogged insulated glass units. The sealant joints around the doors and windows appears to be in good condition.

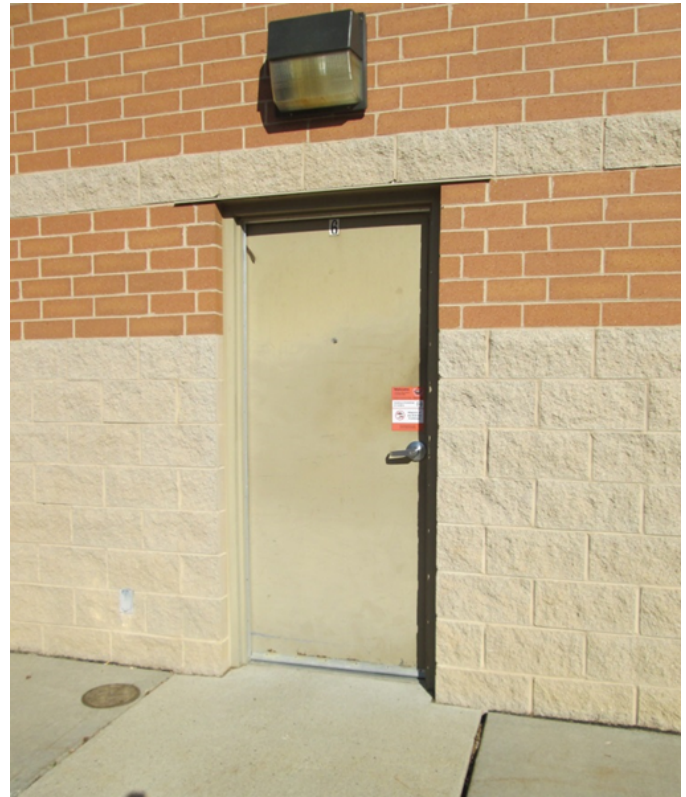
The exterior insulation finishing system (EIFS) soffit at the canopy has some minor staining and some wasp nests that need to be removed.

The painted steel door #6 has stains, rust spots and missing or broken weather seals that need to be replaced.

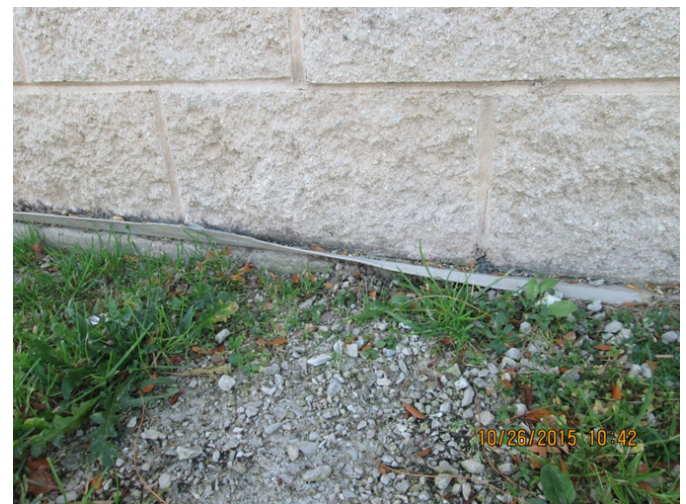
Most of the mortar joints and sealant joints appear to be in good condition. Aside from the discolored sealant, the aluminum louvers for the fan coil units appear to be in good condition. There is some minor damage to the wall flashing drip edge located near Door #2. Some of the exterior light fixtures mounted on the building have discolored lens and faded housing.

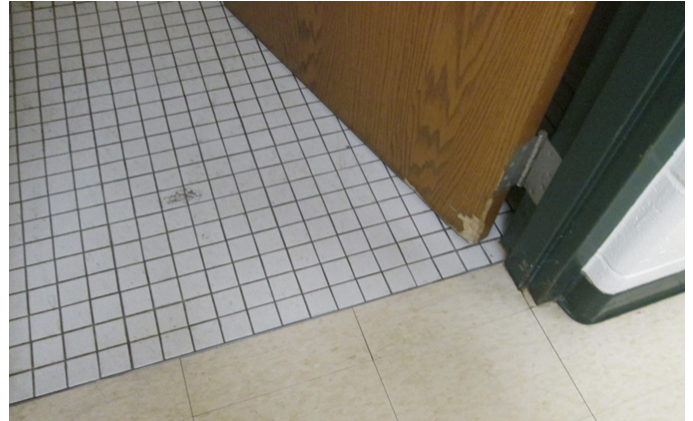
The acoustical ceiling panels in the corridors are in fair to good condition with approximately 3% requiring replacement due to water damage, physical damage and/or staining. The walls mostly consist of painted concrete masonry unit (CMU). The paint on the walls is in good condition, but is starting showing some wear. Most of the doors are stained and varnished oak veneer and are in good condition with some minor scratches, marks and dents. Most of the painted steel door frames have scratches which could be repainted.

The metal hooks and shelving along the corridors appear to be in good condition. The corridors vinyl composition tile (VCT) floors and are in good condition.

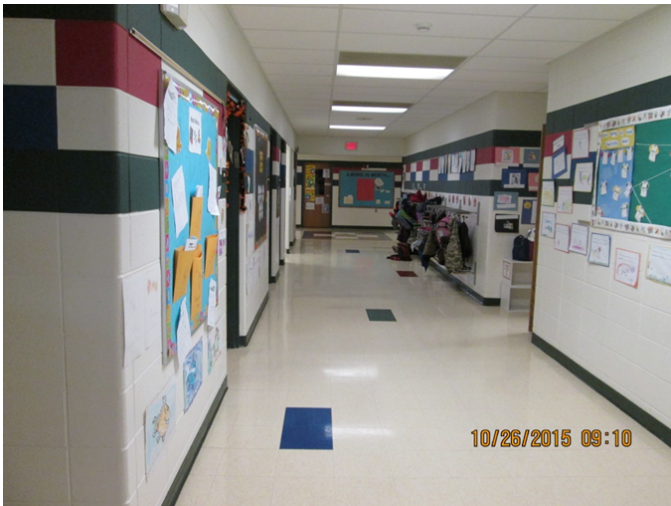
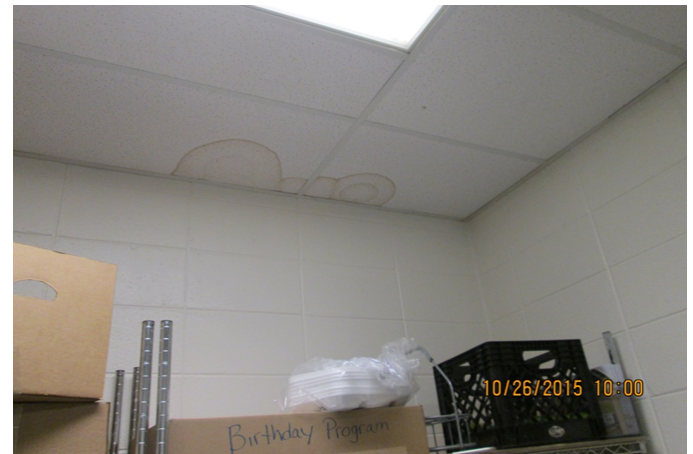
The acoustical ceiling panels in the classrooms are mostly in condition with some minor stains and scratches. Water stains were discovered in a couple of storage rooms and in a small area of the corridor.

Room with sinks on plastic laminate counters are starting to delaminate at the side and backsplash. Also the sealant joint to wall is starting to fail in some areas.
